PROPERTY INSPECTION REPORT

Report #: Sample_New

Concerning: New Construction Avenue, Everytown, TX 76000
(Address of Inspected Property)

By: M Victor Sedinger, #7195 06/03/2008
(Name and License Number of Inspector) (Date)

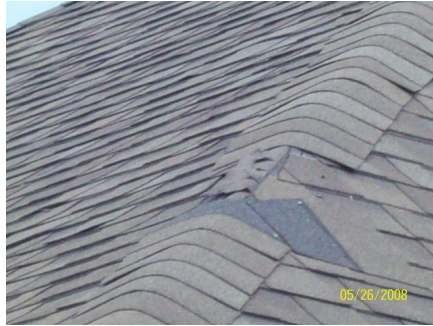
- Coping shingles are missing and/or wind-damaged at northwest hip ridge.
- Nail heads are exposed at the plumbing boots and vent flashings.

Damage shingles, northwest hip ridge

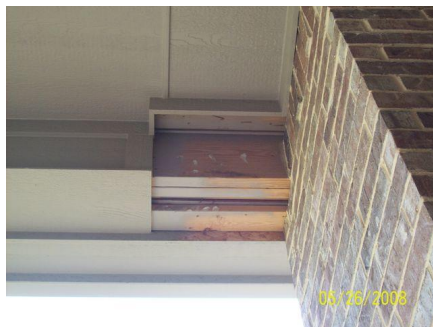
- **Cornice trim is missing at front porch upper walls and ceiling.**

Missing cornice trim, front porch

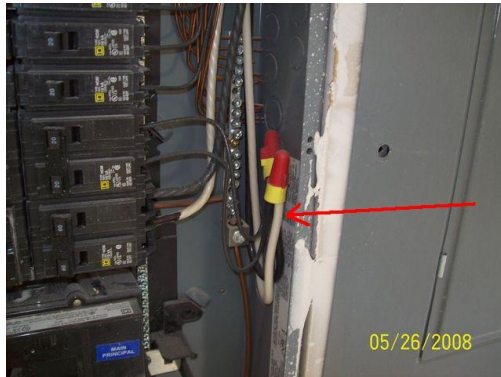
- Wiring at two wire nut splices in left panel exiting splices are not of equal gauge to the wires entering the splices. Inspector recommends that a licensed electrician evaluate and repair as needed.
- Wire nuts present inside left electrical panel. The TREC Standards of Practice state that

any pig-tailed connections or crimp connections present in the panel box shall be reported as in need of repair.

Difference in wire gauge at wire nuts/splices

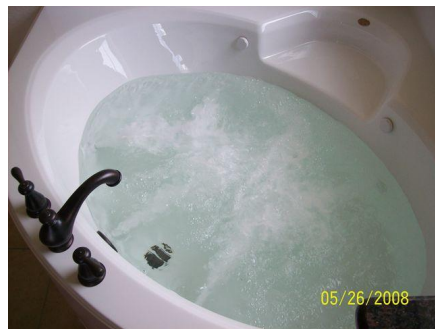
General Information: A whirlpool tub is present. The tub was filled to a level above the water jets and operated to check intake and jets. The pump and supply lines were not completely accessible. The items tested appeared to be in serviceable condition. Ground fault protection is provided at the master bathroom water closet.

Master bathroom whirlpool in operation
