# HouseEXAM

## PROPERTY INSPECTION REPORT

**Report #:** Sample\_Existing

**Concerning:** Common Street, Everytown, TX 76000  
(Address of Inspected Property)

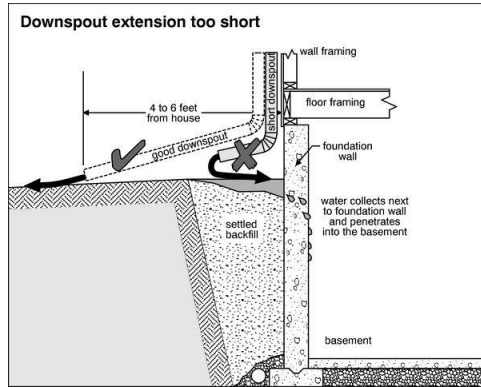
- Observed excessive debris present in the gutters.
- The rain gutter downspouts are terminating by the foundation. This promotes erosion next to the foundation and allows water to pond by the foundation. The rain gutter downspouts should be extended away from the foundation.

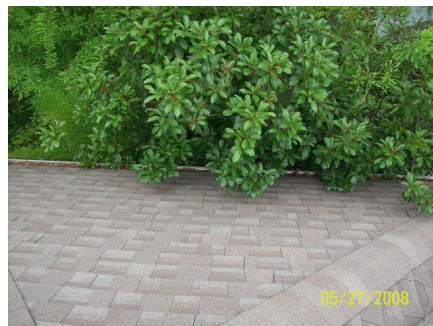
- Scuff and knife marks are present at roof, especially on the rear slope, east end
- Nail heads are exposed at the plumbing boots and vent flashings.
- There are tree limbs and/or shrubs in direct contact with the roof at west and north sides.

Tree limbs in contact, west side

All trees should be trimmed back 3 to 5 feet from the structure. When trees are close to the house, their limbs should never touch the building, or serious damage can result.

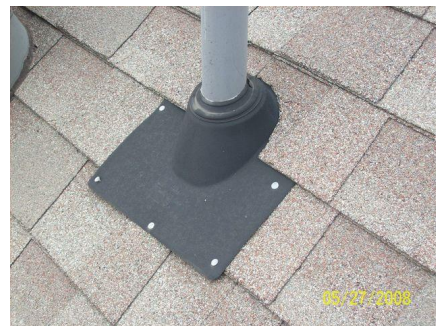
Exposed nail heads at vent boots

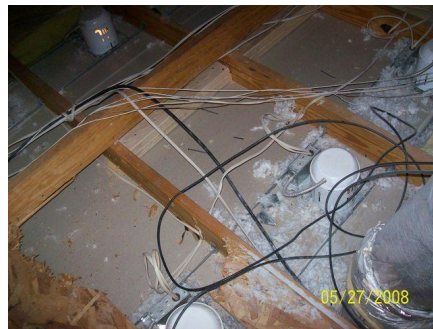
- **No insulation present above kitchen. Insulation should not contact recessed light fixtures directly.**

No insulation present above kitchen

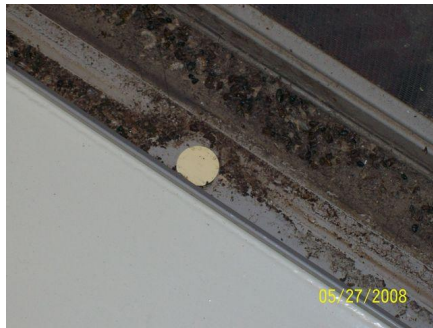
- Tensioning spring is dislodged and in need of repair at left window in southeast bedroom.
- Security contacts in window sills have not been sealed/caulked at several windows, including, but not limited to: dining room and upstairs front bedroom. Silicone caulk/sealant is required at these locations to prevent water intrusion inside the wall cavities.

Sealant missing at window security contacts

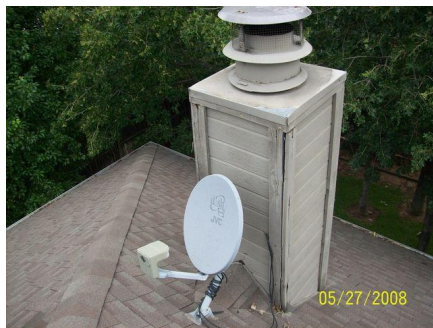
- Observed excessive creosote in the chimney flue. Recommend a qualified chimney technician evaluate and repair as needed.
- Wood trim at chimney is deteriorated from weather damage. Recommend repair and re-painting to prevent further damage and/or water penetration to interior.

Wood trim water damaged at chimney

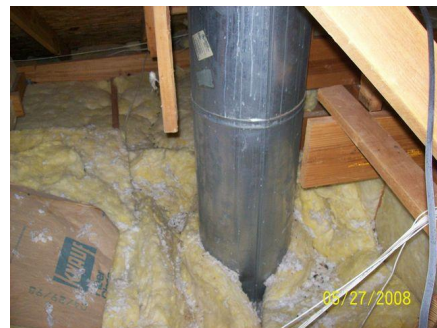
Insulation in contact with chimney flue

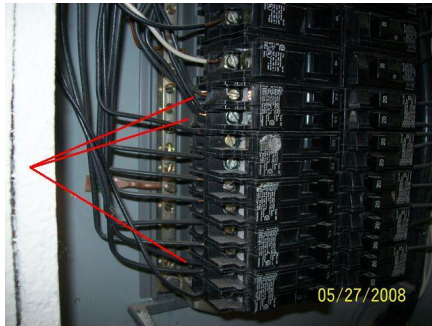
- No fewer than three 15-amp circuit breakers in the panel are double-lugged (i.e., two wires on one breaker). Only one wire allowed per terminal on this brand panel equipment.
- Inadequate service clearance in front of the main electrical panel. Clearance required for safety in front of the panel is 30" wide X 36" deep X 78" tall.

Double-lugged breakers in panel

**Type of Wire:** Copper wiring was observed in the main panel. No aluminum wiring present. **Due to issues in this and the following section, Inspector recommends that a licensed electrician evaluate the electrical system, report and repair as needed.**

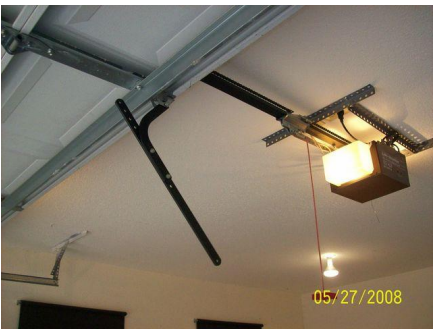
p	..	..	p		<p><b>I. Garage Door Operators</b>  <i>Comments:</i>                  Due to the issues identified below, Inspector recommends that a qualified garage overhead door installer evaluate the system and repair as needed.</p> <ul style="list-style-type: none"> <li>• Unit has been unplugged.</li> <li>• Overhead garage door pivot arm has been mechanically disconnected.</li> <li>• Drive chain does not operate when unit is energized.</li> </ul>
---	----	----	---	--	---

Operator not connected at garage door
