HouseEXAM

PROPERTY INSPECTION REPORT

Concerning: 124589 Glorious Lane, Fort Worth, TX 76001
(Address or Other Identification of Inspected Property)

By: M Victor Sedinger, Lic #7195 01/27/2019
(Name and License Number of Inspector) (Date)

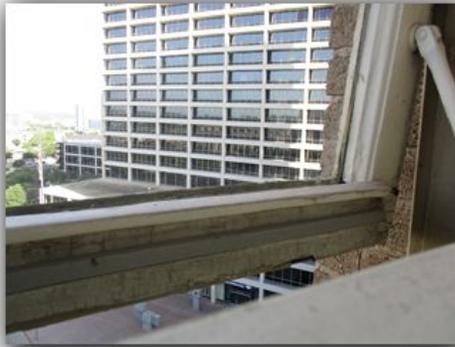
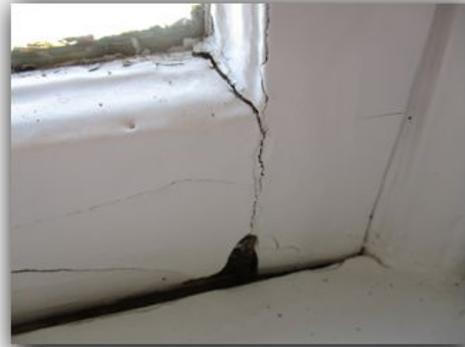
- Window glazing (glazing putty) is brittle and broken at numerous windows. Recommend replacement of this weather-proofing compound to improve weatherproofing qualities in the house.
- Foam rubber strips are present at several windows, indicating ongoing air leakage and thermal transfer in these locations. Recommend asking Seller for more information. Contact building maintenance for repair.
- Lower right edge joint should be repaired at far left window in living room.

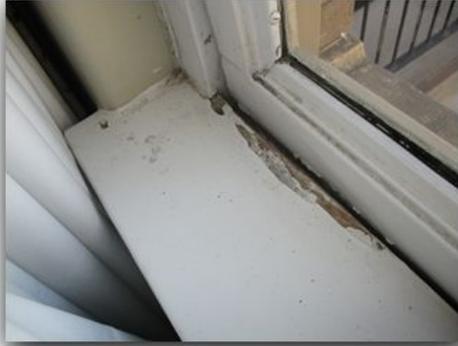
- Observed what appears to have been water intrusion* on the interior sill at the window in master bedroom south window. Paint is peeling, chipping or sill is warped.

*FYI: This type of intrusion is fairly common and is mainly related to three things:

1. Condensation developing on the aluminum frame of the window.
2. Blowing rain coming in the window around the seals.
3. Water sprinklers that may be spraying on the structure.

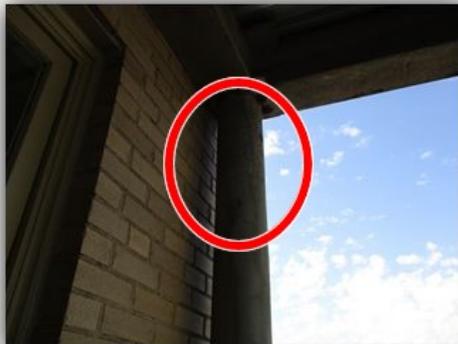
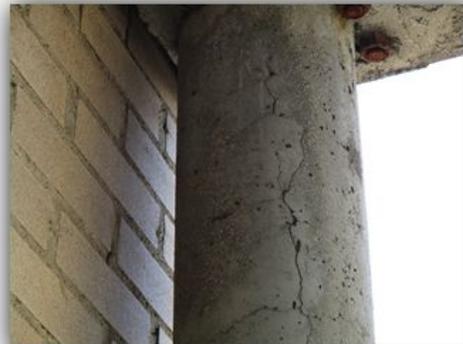
- Concrete casement at southeast column on the balcony is cracking and appears in the early stages of deterioration (photo below). Recommend repair of the concrete surface to prevent further deterioration and possible falling debris to areas below.

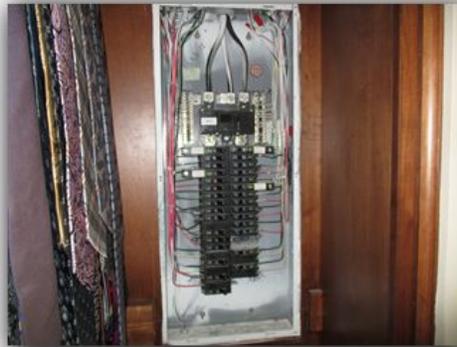
- The electrical panel for the house is located inside the master suite clothes closet. While this location was allowed by older electrical standards, current national codes do not permit panel locations in clothes closets. TREC Standards of Practice section 535.230 states to "report as deficient a panel that is installed in a hazardous location, such as a clothes closet."

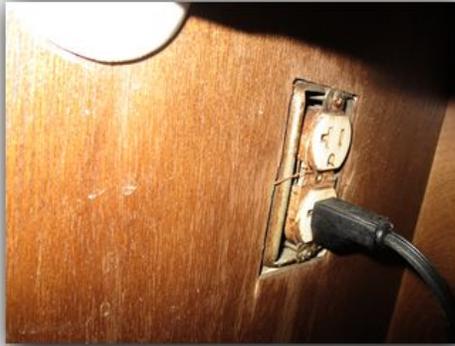
- Ground fault protection is not present at the receptacle on the west end of the kitchen counter peninsula. All receptacles in kitchen locations are required to be protected.
- Touch-contact switches at two locations were more difficult to operate than the remainder of those type switches in the residence. Those locations were: front entry (switch for entry ceiling fixture), and switch to the left of the north bathroom vanity sink (for ceiling light above the tub).
- Cover plate missing under kitchen sink for power to the disposer.

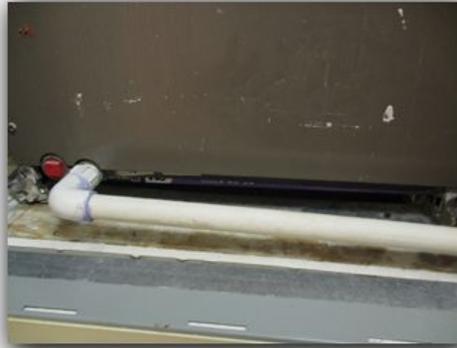
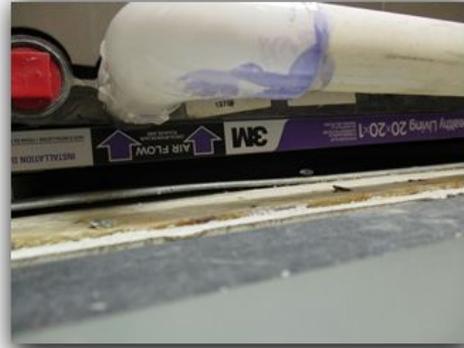
- Temperatures at supply registers in north bedroom ceiling, and at kitchen ceiling, indicate a likely air flow obstruction in the chase/duct work supplying these vents. Measurements indicated temperatures only slightly cooler than return air register temps. Chart below will list temperatures measured at various rooms. Red numbers will indicate possibly obstructed vents. It should be noted that ALL registers were in the open position at time of inspection.

Room	register (supply)	additional supply register in room
North bathroom	75	
North bedroom	75	75
Kitchen	76	
Ceiling west of kitchen	74	75
Living room (east vent)	57	59
Living room (ceiling west)	59	
Den (TV)	54	
Master bedroom	55	59
Master bathroom	53	
Study	55	
South hallway	55

Based on the issues described in this section of the report, Inspector recommends that a licensed HVAC technician evaluate the conditions described for cause and remedy, as well as price estimates, prior to the close of the option period **or any other applicable time restraints.**

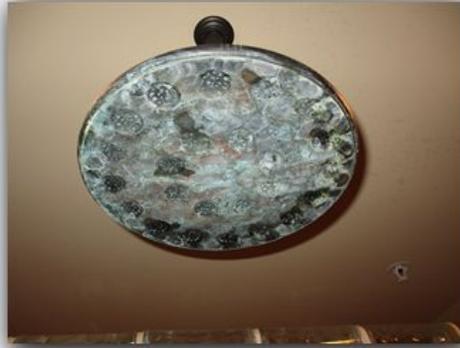
FYI: The corrosion on the face of the master bathroom shower head is from mineral deposits, and can be cleaned off with any cleaner that reduces calcium or lime deposits from metals. Do not use harsh chemicals that will damage the metal surface.

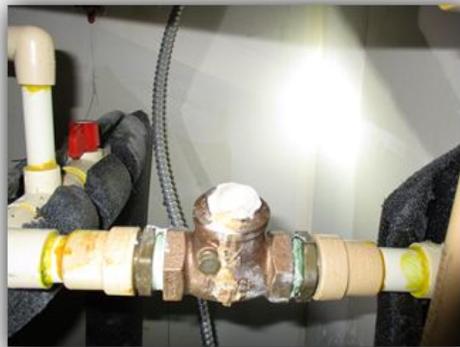
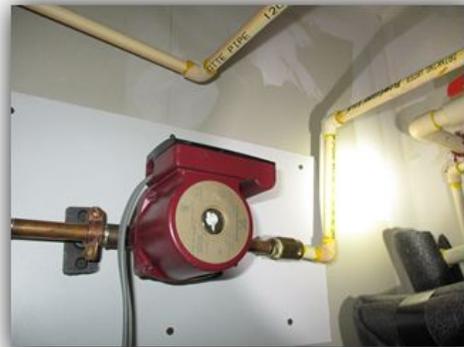
- Observed corrosion at the check valve above the water heater. Inspector recommends further evaluation by a licensed plumber, and repair as needed.

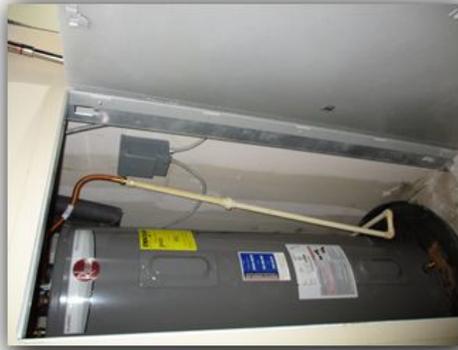
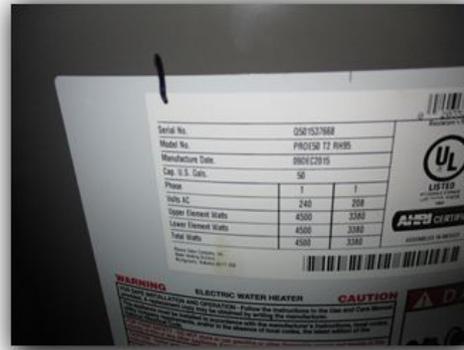
- Caution: Hot water temperature at fixtures in the house is excessively high. Temperatures above 120° are a risk for scalding, especially for children. Recommend lowering thermostat settings at the water heater, or installing tempering valves at fixtures where bathing and showering are performed. Any needed evaluation or subsequent repairs can be performed by a licensed plumber..

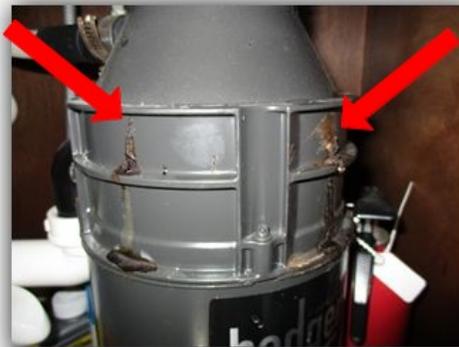
- Observed two leaks at the disposer unit case. Recommend replacement of the appliance.
