HouseEXAM

PROPERTY INSPECTION REPORT

Concerning: 13579 Grumbling Lane, Fort Worth, TX 76001
(Address or Other Identification of Inspected Property)

By: M Victor Sedinger, Lic #7195 01/27/2019
(Name and License Number of Inspector) (Date)

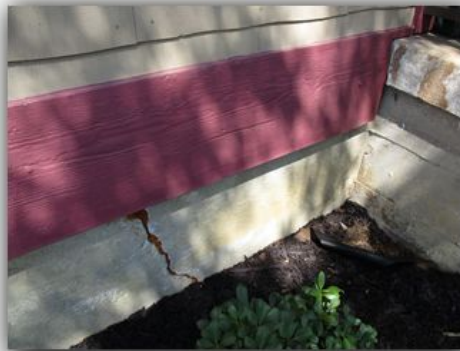
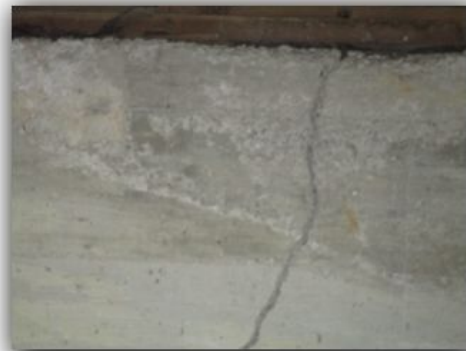
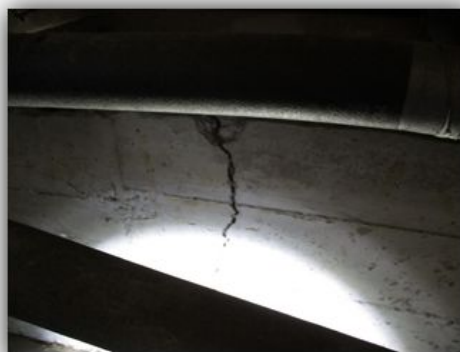
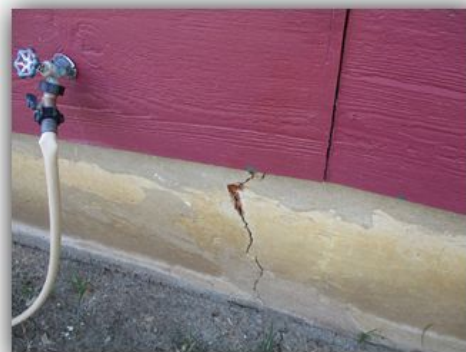
Inspector's Opinion on Foundation Performance: In the Inspector's opinion, the foundation appears to be performing as designed and fulfilling its intended purpose of providing support and stability to the structure. However, there are some indications of previous foundation shift or movement. Those indicators are:

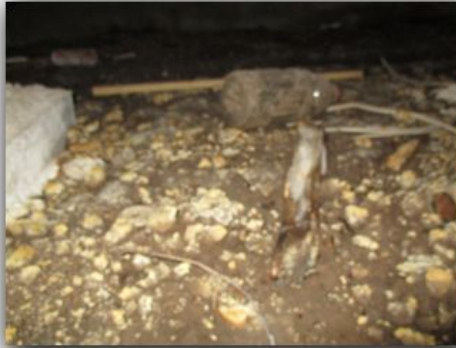
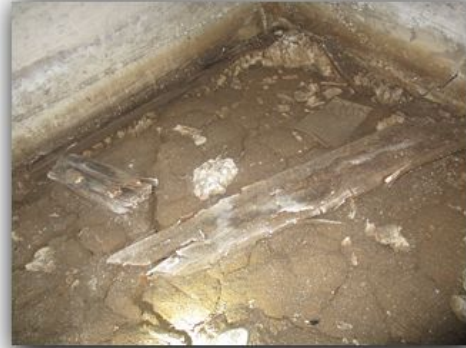
- Crawlspace - It appears that additional concrete has been added to the top of the piers in a majority of locations. Shimming of piers, in this condition would only exacerbate the problem of high spots in the floors. **Any evaluation or subsequent repairs, related to foundation adjustment or repair should be referred to, and performed by a qualified foundation repair specialist.**
- Crawlspace - Remove all wood debris from crawlspace. This condition is conducive to termite and rodent infestation. Also any construction materials or other trash should be removed. (Handyman service would be adequate).

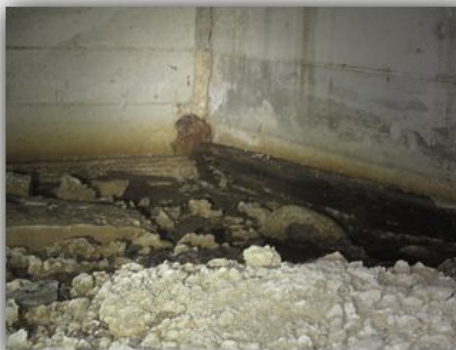
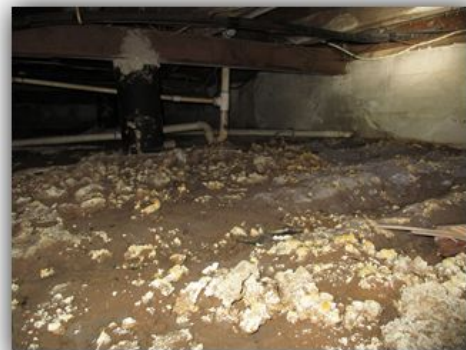
Monitor Condition: Dampness in Crawlspace: Observed damp area(s) in crawlspace, especially at west (higher elevation) end. Client should monitor this condition over time, and contact a qualified foundation specialist for evaluation if condition worsens/continues, or if water stands in any area for more than 24 hours following a rain.

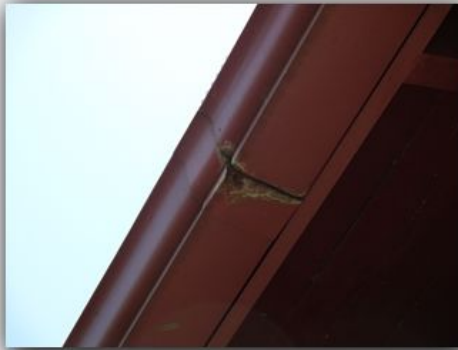
- Gutters leak at the splice joints in two or more locations. This causes erosion at the soil, but also premature corrosion at the gutter equipment. Any evaluation or subsequent repairs should be performed by a qualified handyman type service.

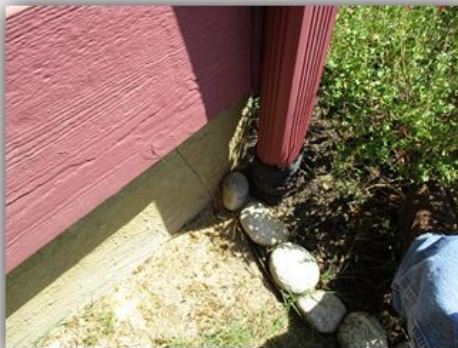
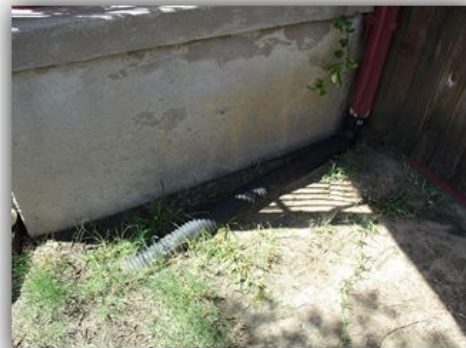
FYI: Sub-surface Drainage Present: A sub-surface drainage system is present on the property. Testing of the system is beyond the scope of this inspection. However, the owner should examine it for clear access, and keep grass and debris from blocking the collection grids or termination points.

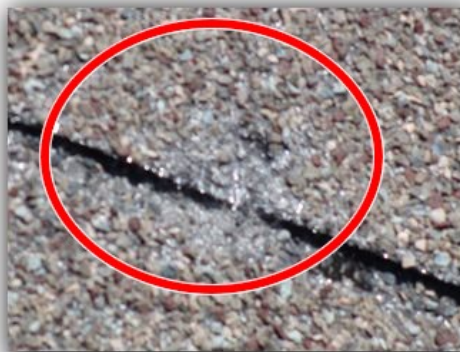
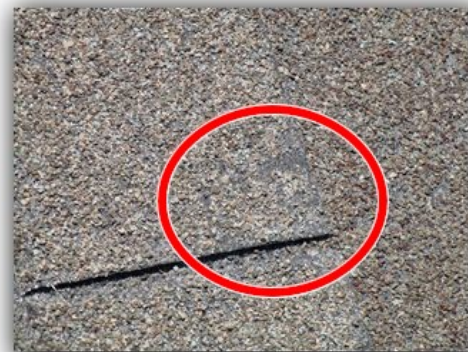
- Observed possible hail damage visible on shingle surfaces at south slope. A qualified roofing specialist should evaluate. Recommend Client ask Seller for history of repairs, insurance claims and/or insurance payments.

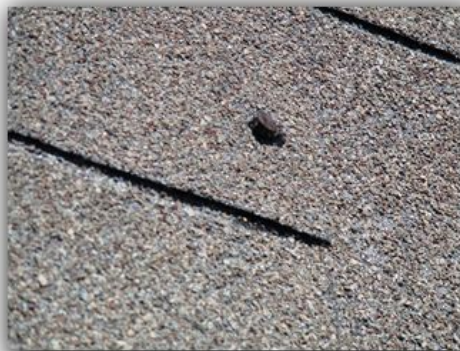
- Nail head visible at south slope near the ridge. Recommend proper repair by a qualified roofing specialist.

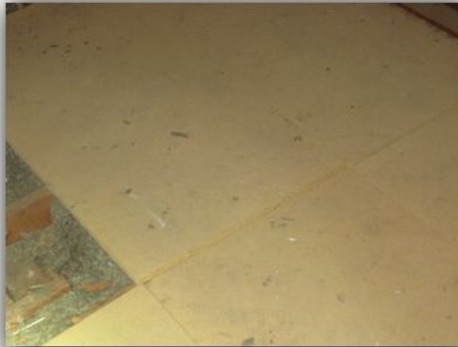
- Floor decking in the attic appears to be of inadequate thickness or building material for adequate support of foot traffic. Also, ends and edges are not properly secured in some locations. Care should be used when walking in attic.

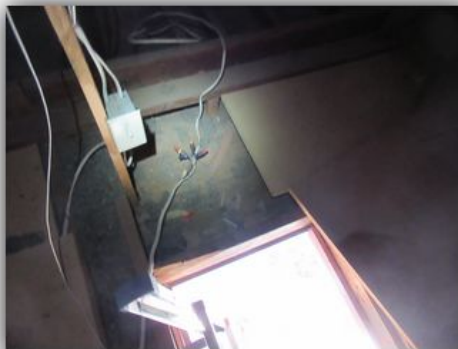
- Observed exposed wiring cables/splices in the attic. (photos below) All electrical connections of this type are required to be enclosed inside an accessible junction box, with a cover plate. A licensed electrician should perform any such repairs.

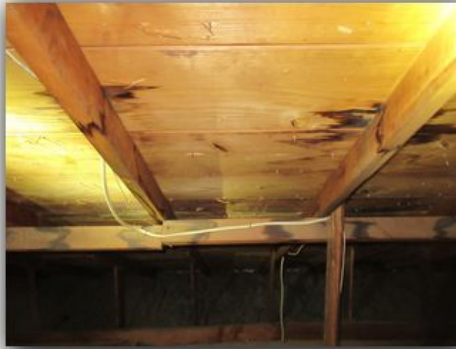
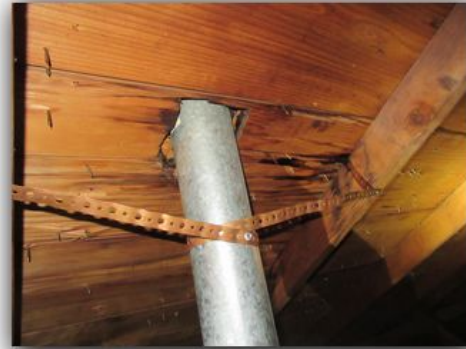
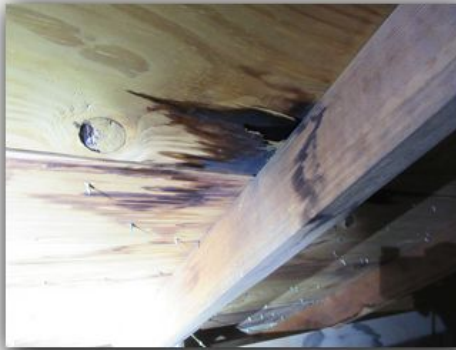
FYI: Evidence previous water intrusion inside attic: Though water stains appear to have occurred during a time prior to the current roof covering, Inspector is required, by the Standards of Practice, to report evidence of water intrusion. Photos below are representative of several locations in the roof decking, where water had previously leaked.

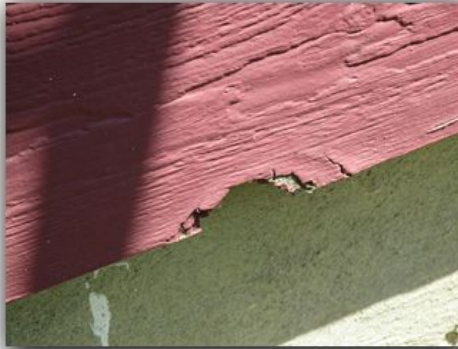
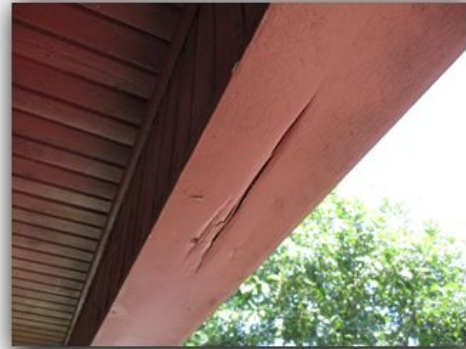
- Wood trim and/or siding is water damaged and deteriorating at several locations, including, but not limited to: south side lower wall, header above porch steps, etc. . Recommend repair/replacement and re-painting to prevent further damage.

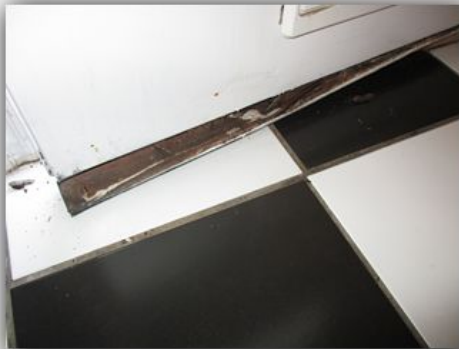
- Wood slab at rear entry door has rotted. Weatherstripping sweep at bottom has fallen out. Door should be replaced by a qualified trim carpenter.

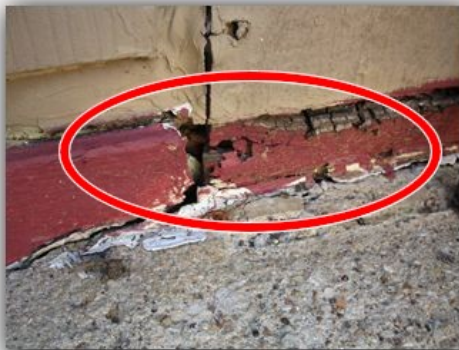
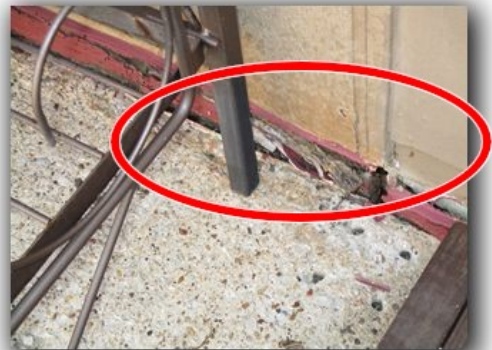
- Wood trim is water damaged or rotted and deteriorating at the abandoned rear entry door. Recommend replacing all damaged portions, re-painting and re-sealing trim to prevent further deterioration.

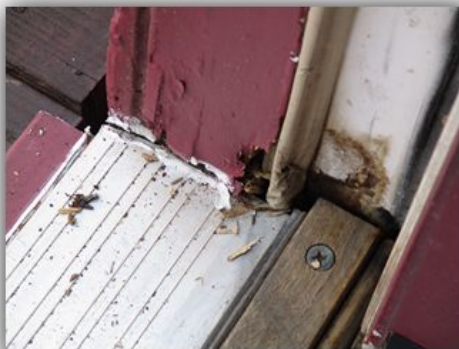
- Rear entry door wood trim is water damaged and deteriorating. Recommend replacing any damaged portions, re-painting and re-sealing trim to prevent further deterioration.

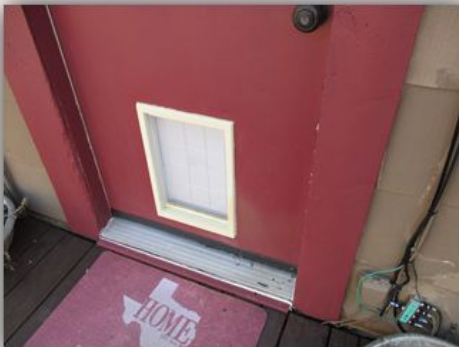
- The pet door in the west exterior entry door constitutes a potential security risk. Recommend replacement of door or permanently sealing the breach.

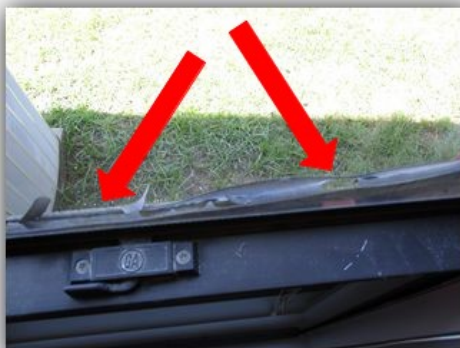
- Plastic glazing bead cracked and damaged windows in the back bedroom and front-facing window in living room.. This damage is consistent with the damage caused by a hail. Recommend asking Seller for more information.

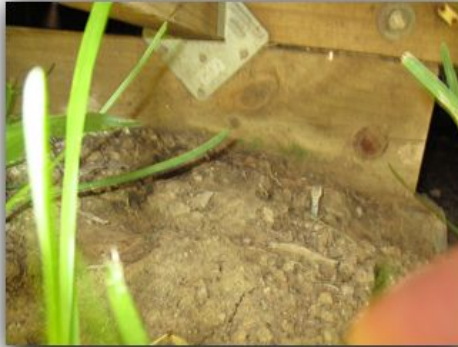
- Guardrail at front porch is loose and should be secured properly.
- A guardrail could be added to the rear deck to provide an extra measure of protection.
- Portions of the deck framing at the back porch are lying in direct contact with soil. This is a condition considered conducive to wood destroying insect infestation. Inspector is a licensed pest control applicator or technician.

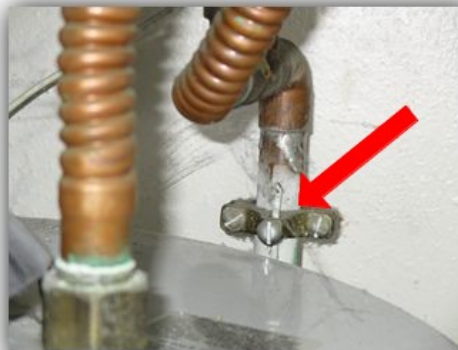
Delivery & Capacity of Service: Service delivery provided: Overhead
Service entry located: West side of house
Main panel located: West side of house
Capacity (if able to confirm): Rating Not Determined, 120/240 volt;
Panel manufactured by: General Electric
Grounding method(s): Cold Water Ground (photo below)

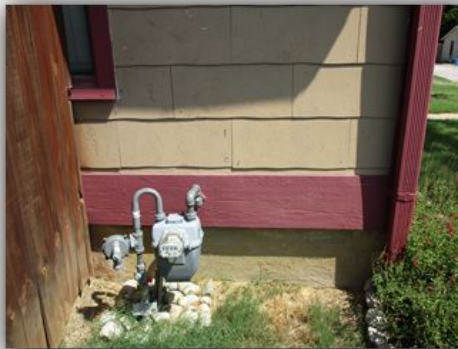
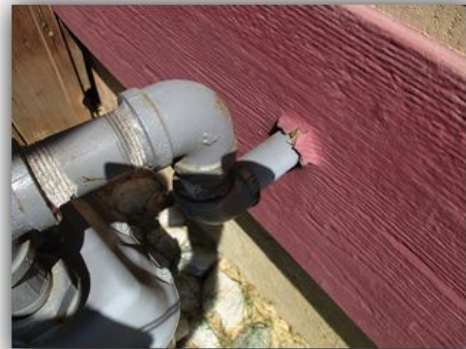
- Inspector was unable to locate or identify any provisions for bonding the metal gas piping to the electrical grounding system. Due to the specialized nature of this deficiency, Inspector recommends further evaluation by a licensed electrician, and repair as needed. (FYI: Texas Real Estate Commission requires "lack of bonding on gas piping,..." to be reported as Deficient. See page 2 of this report: "TEXAS REAL ESTATE CONSUMER NOTICE CONCERNING HAZARDS OR DEFICIENCIES").

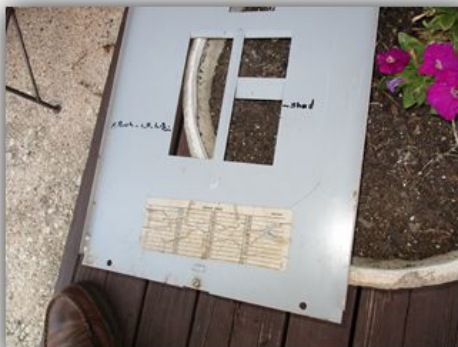
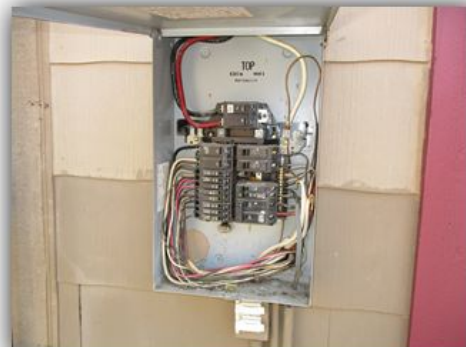
- Rodent and gecko feces in panel. Recommend sealing all open panel entry points..
- Labeling at the breakers for individual circuits inside the main electrical panel is incomplete and unreadable.

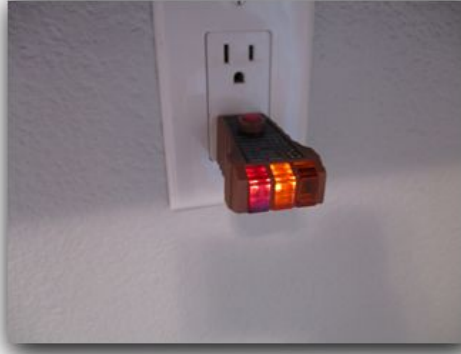
- Smoke detector is loose at the ceiling in front bedroom.
- Cover plate missing at receptacle above microwave.

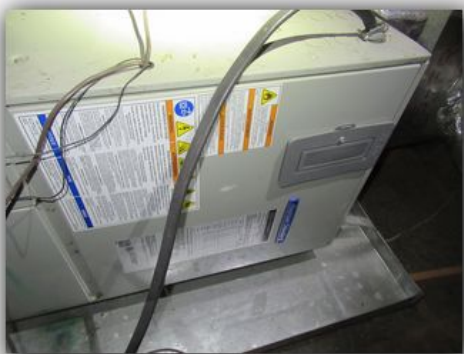
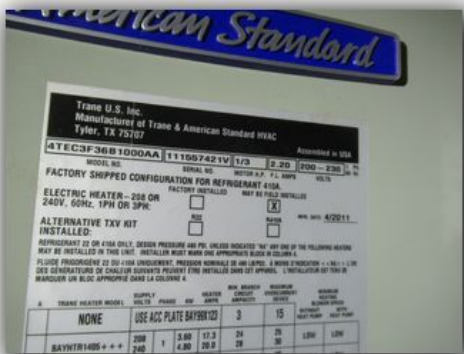
- Inadequate footing area for decking in front of and leading to the HVAC equipment in the attic.

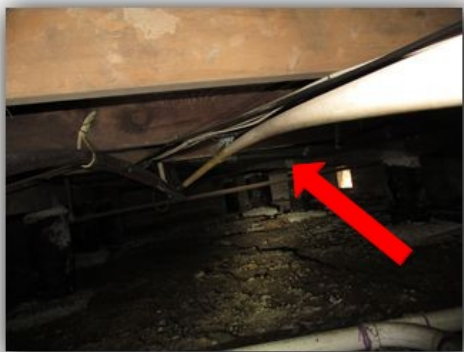
- Primary condensate drain line has a negative drain angle in the line inside the crawlspace. Re-routing of this line will allow proper drainage, and minimize clogging.
- Inadequate footing area for decking in front of and leading to the HVAC equipment in the attic.
- Insulation is dislodged and/or missing at portions of the refrigerant line inside the crawlspace.

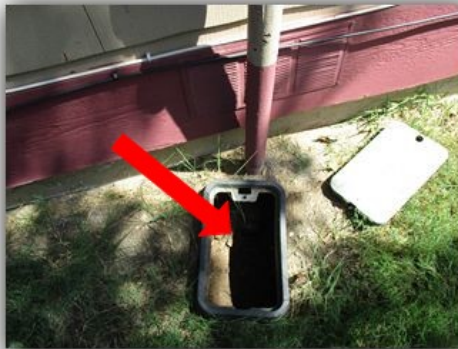
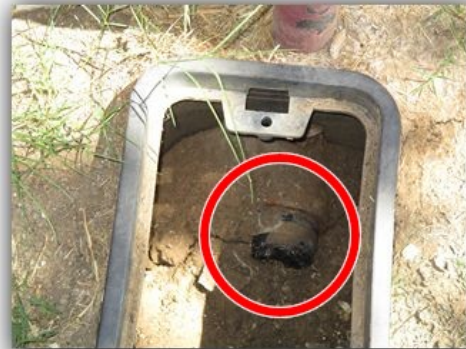
FYI: Cast Iron Pipe Remaining: Some of the sewer/drain piping has been replaced with PVC. However, inspectors observed exposed cast iron sewer/drain line at the south exterior. It appears that portions of the drain lines in the house are still cast iron pipe (in this case, the kitchen drain line). A rubber cap is present in a pit (photo below) at this location to serve as a cleanout.

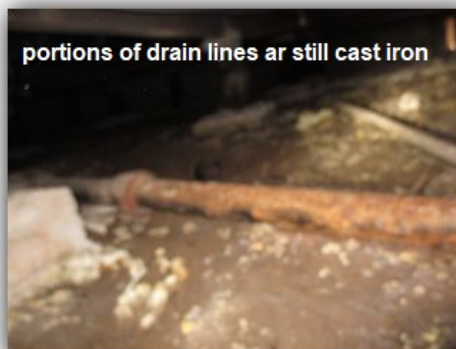
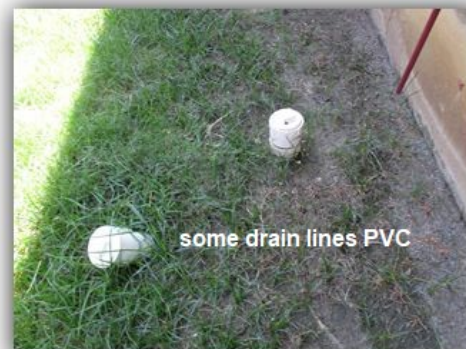
- Cast iron drain lines are present at the property. Drains at the property performed in a satisfactory manner at time of inspection. Due to the latent defects sometimes experienced with this material, client may want a licensed plumber to evaluate the entire drain system and its components, and advise and repair as needed. "Scoping" the drain lines using a closed circuit camera is also sometimes advisable.

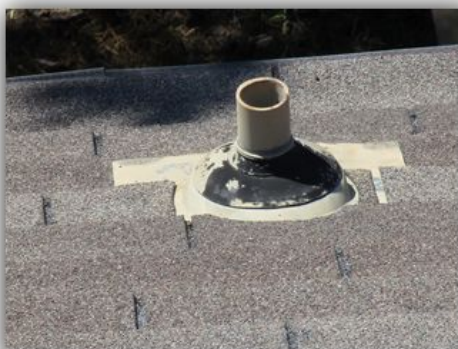
- Rooftop drain vent pipe above the kitchen appears to be shorter than minimum height requirement above the roof surface. Efficient drain performance requires proper roof pitch-to-vent height ratio. Client should monitor for slow or noisy drains at the fixture(s) in this bathroom, or contact a licensed plumber if drain problems develop.

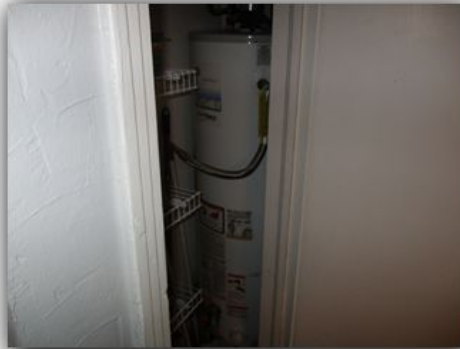
- Water heater is installed in a location (adjacent to a bedroom) that could potentially leak to the interior, but there is no safety pan or drain line to the exterior. Texas Real Estate Commission Standards of Practice (535.229.k.9) requires that this condition be reported as a "Deficiency."
- Brass flex connector tubing is no longer approved material for supply line with natural gas. Natural gas reacts with copper and/or brass alloys over time, and leaks can develop. Evaluation and repairs should be performed by a licensed plumber.

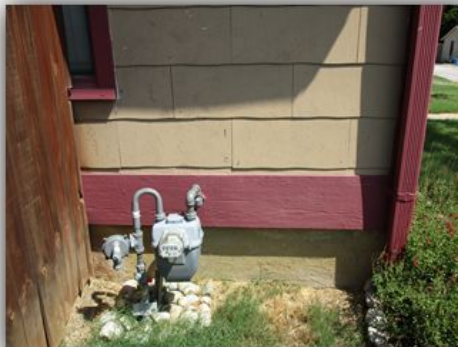
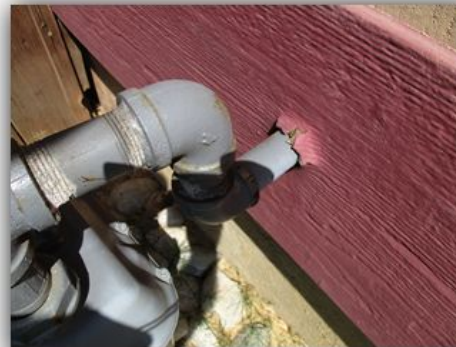
- Inspector was unable to locate or identify any provisions for bonding the metal gas piping to the electrical grounding system. Due to the specialized nature of this deficiency, Inspector recommends further evaluation by a licensed electrician, and repair as needed. (FYI: Texas Real Estate Commission requires "lack of bonding on gas piping,..." to be reported as Deficient. See page 2 of this report: "TEXAS REAL ESTATE CONSUMER NOTICE CONCERNING HAZARDS OR DEFICIENCIES").
