HouseEXAM

Report ID: Slab on Grade Sample

PROPERTY INSPECTION REPORT

Concerning: 123 One Hundred Twenty-third Street, Fort Worth, TX 76001
(Address or Other Identification of Inspected Property)

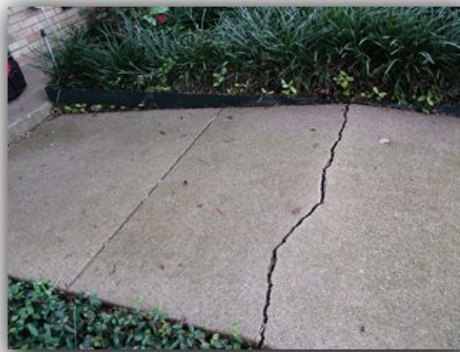
- Front approach walk is buckled near the front porch. It appears that tree roots are the cause, but the condition is causing a trip hazard and should be evaluated by a qualified paving contractor.

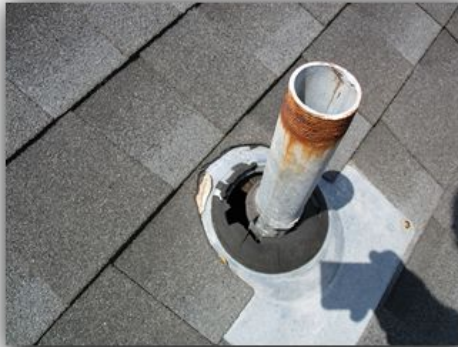
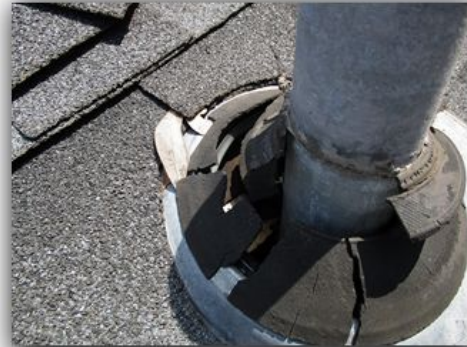
- Roof drain vent boots are deteriorated and letting water into the attic spaces at several locations.

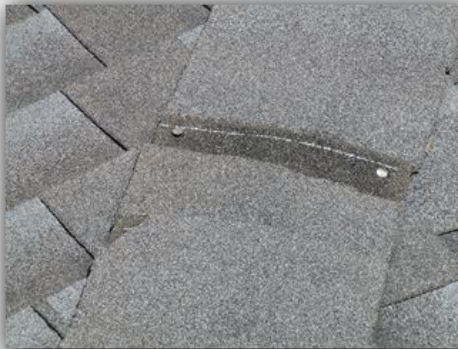
- Shingle tab missing/broken at northeast hip ridge.

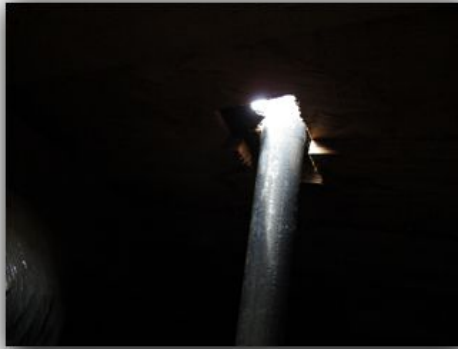
- Daylight observed inside the attic below locations where drain vent boots are damaged, or deteriorated. Any evaluation or subsequent repairs should be performed by a qualified roofing specialist.

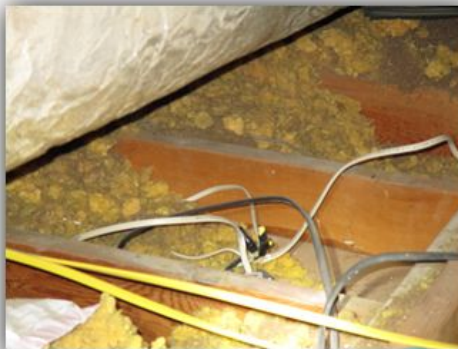
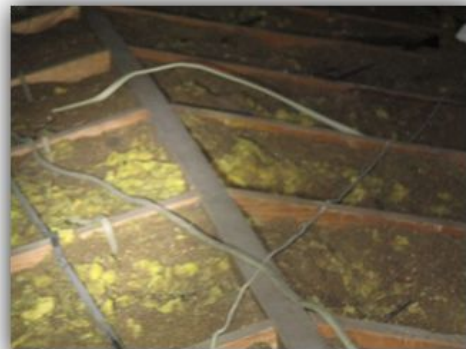
- Insulation missing at one or more locations inside the attic.
- Depth of insulation in the attic appears inadequate to significantly restrict heat loss.
- Some items stored in the garage attic are heavier than advisable for storage in the space. Inspector is concerned that the stress cracks in the garage ceiling were caused by improper framing and blocking when the attic fan, attic ladder, and attic decking were installed.

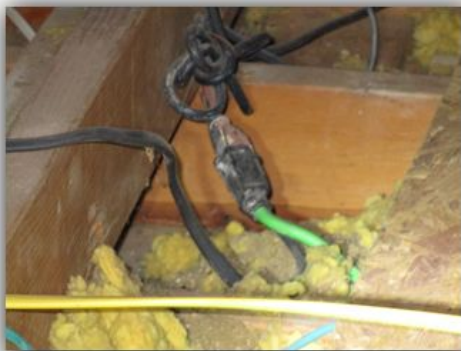
- Observed exposed wiring cables/splices in the attic. (photos below) All electrical connections of this type are required to be enclosed inside an accessible junction box, with a cover plate. A licensed electrician should perform any such repairs.

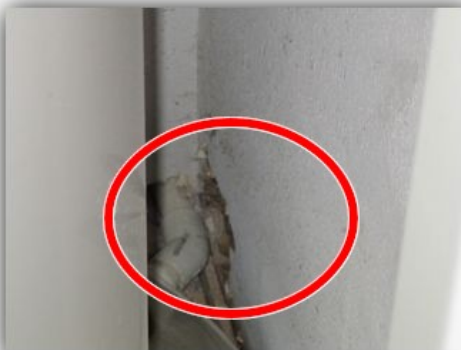
- Unfinished wall repair observed at the wall in the lower wall right of north water heater.

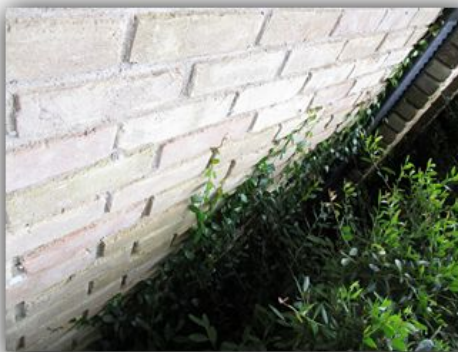
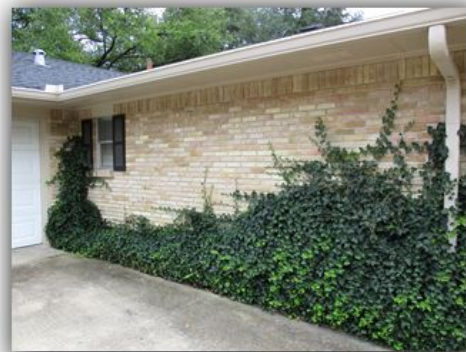
- Observed vegetation/foliage in direct contact with the exterior of the structure. All plants and shrubs should be trimmed 3 to 5 inches away from the structure, to minimize wood rot and potential insect damage in siding and trim.

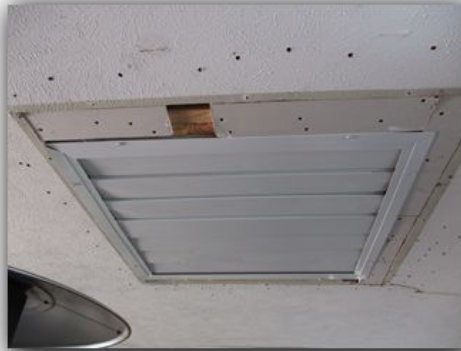
- Attic fan at garage ceiling presents a potential breach of the firewall between the garage and the attic. Recommend repair or replacement of the drywall barrier at this location.

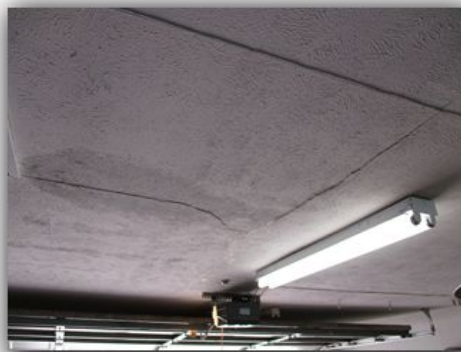
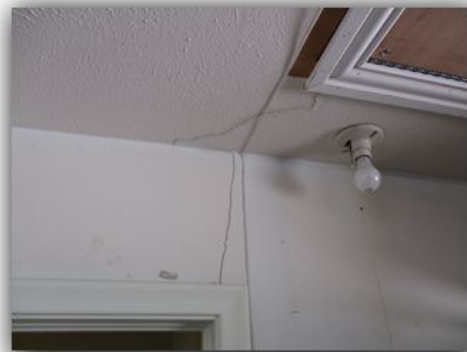
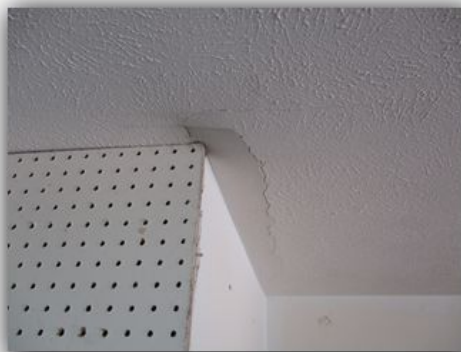
- Stress cracks in the garage ceiling appear to have been caused by improper framing of the attic ladder and attic fan installation. Decking in the attic above the garage prevents visual inspection of the ceiling joists. When attic is empty the decking should be taken up to view the condition of the framing underneath.

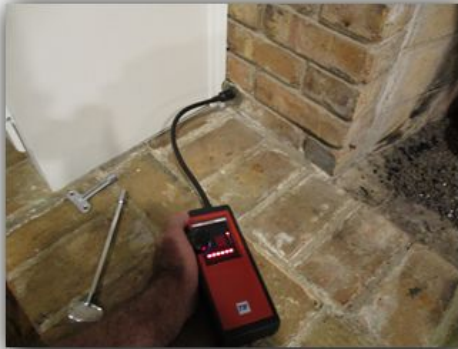
- Gas leak detected at the fireplace gas valve. Combustible gas detector registered the leak only when the valve was in the ON position. Recommend repair by a licensed plumber ASAP.

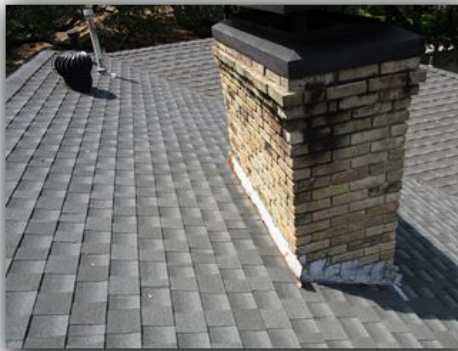
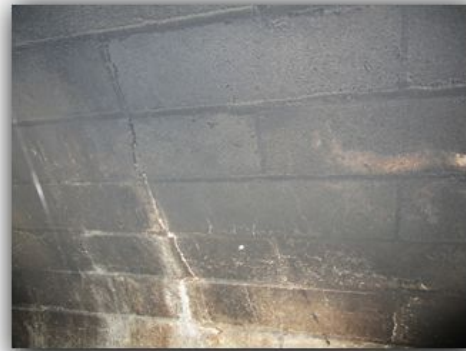
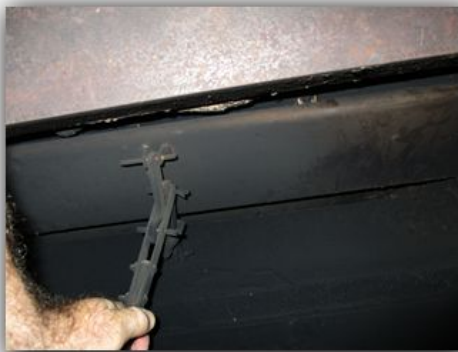
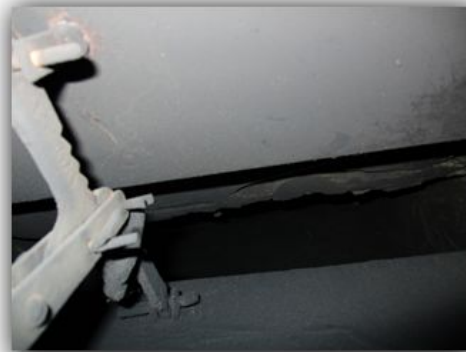
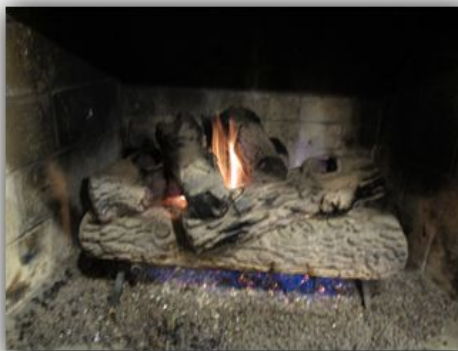
- Observed light-to-moderate amount of creosote build up inside the chimney flue. Periodic cleaning by a professional chimney sweep or certified chimney technician is recommended.
- The firebrick is cracked and/or loose inside the firebox. There are bricks that are cracked and/or loose in the firebox. This condition should be further evaluated and corrected as necessary.
- The damper is will not close tightly. Recommend repair by a certified chimney technician.
- A cricket/saddle is not present at the up-slope side of the chimney. A cricket is required to provide diversion of water around the chimney at the roof.

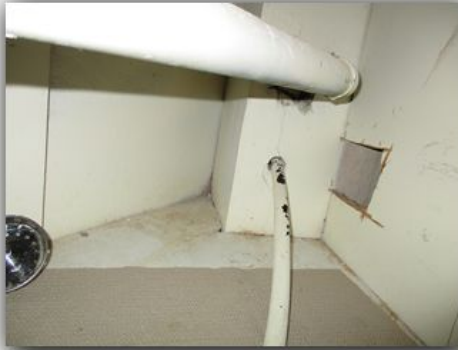
- Steel wool in use inside the base cabinets under kitchen sink and wet bar. This typical of rodent intrusion, perhaps infestation. Recommend asking Seller for more information.

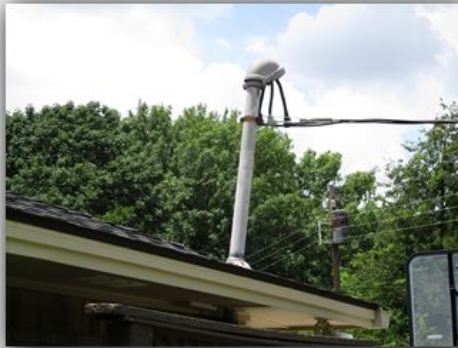
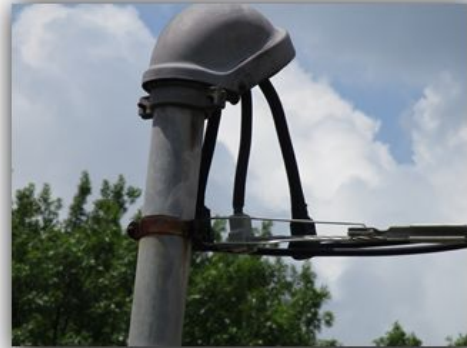
- Service entry mast is bent, and drip loops have been stretched beyond tolerance at the service entrance equipment, northwest corner of garage. (photo below)

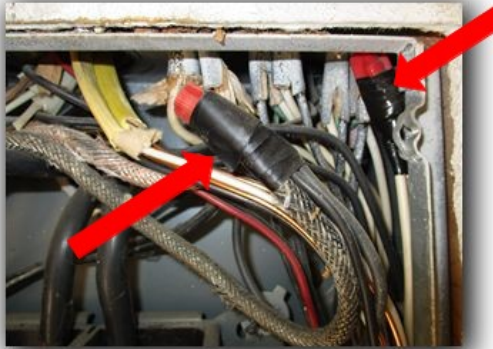
- Observed two or more wiring splice(s) in the upper right corner of the panel that have no fewer than three wires entering the splice. (photo below) Each such splice attaches a minimum of two circuits to one breaker. Only one circuit is allowed to be attached to each breaker. Recommend evaluation by a licensed electrician and repair as needed.

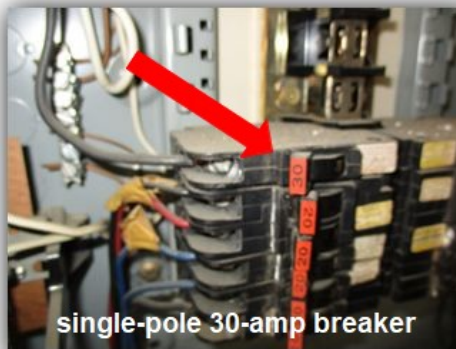
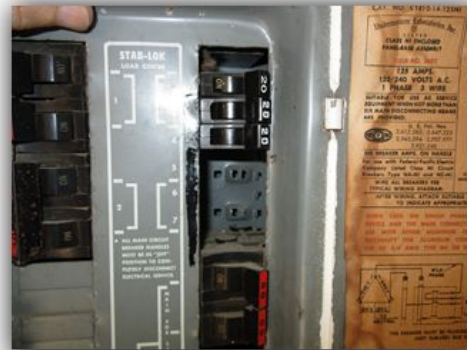
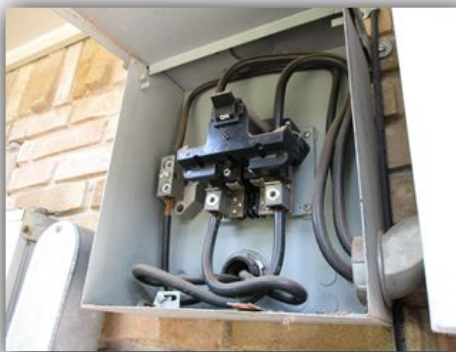
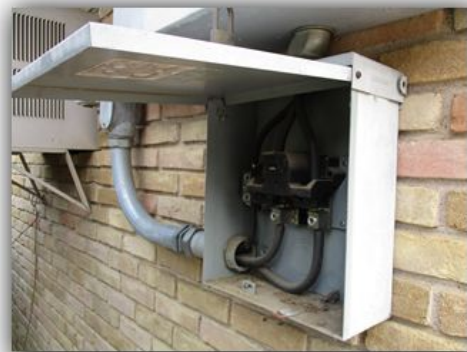
- A single pole 30-amp breaker is present at the upper left breaker in the left panel. The wire is leading to the exterior outlet at the north side of the garage.
- Three or more knockout and/or twistout tabs missing in the left panel front. Interior exposed.

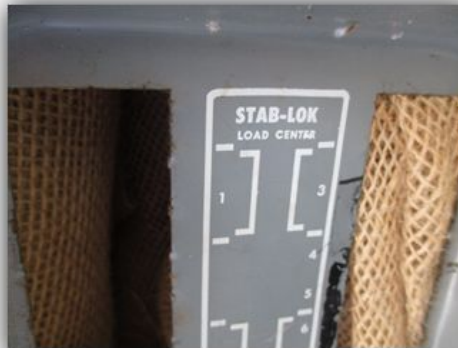
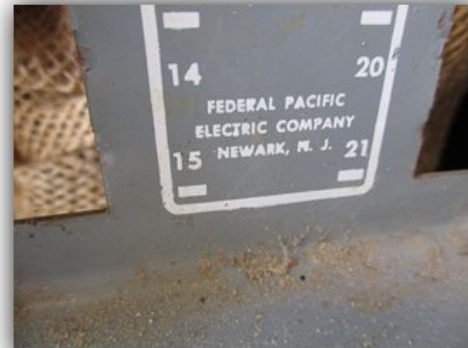
- **Consumer Information Notice: FPE panel:** The electrical panel is Federal Pacific (Electric) brand equipment, using Stab-Loc circuit breakers. Client should be aware that many electrical experts consider the equipment inferior due to a record of design flaws and service recalls. On the other hand, there are millions of FPE panels which have been functioning in a perfectly satisfactory manner for over 30 or 40 years without defect. Since there are specific issues listed in this section which require the attention of a licensed electrician, Inspector recommends a thorough evaluation of the condition of the Federal Pacific panel equipment

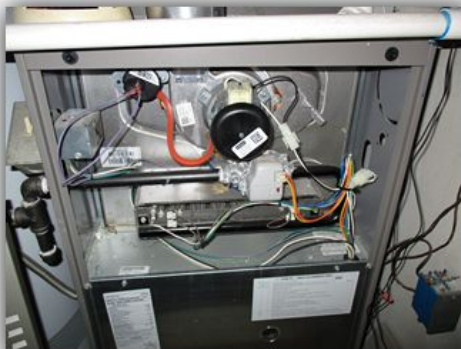
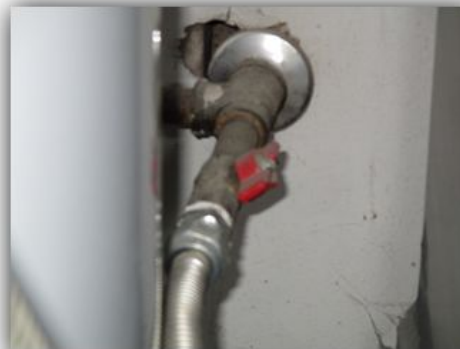
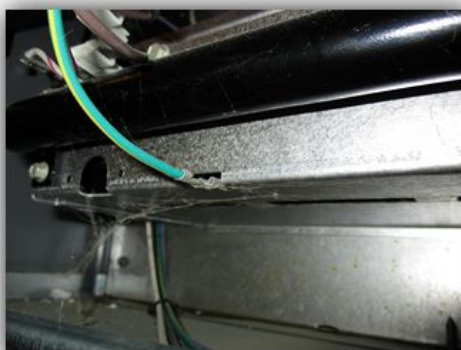
- Air source in the mechanical closet is inadequate for proper combustion at the gas-fired furnace. Recommend evaluation and repair by a licensed plumber or HVAC technician. (See diagram below for one possible repair scenario).

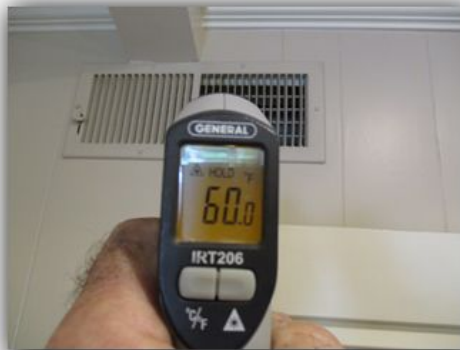
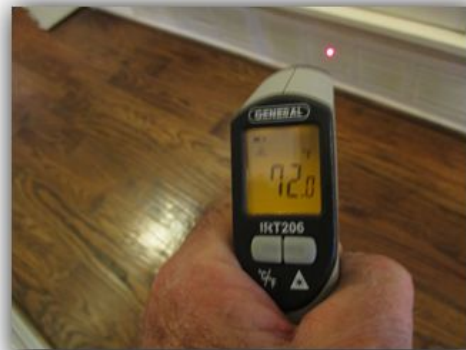
Supply Air Temp: **60°** Return Air Temp: **72°** Differential: **12°**

The temperature differential **is not** within the range of 15° -21°.

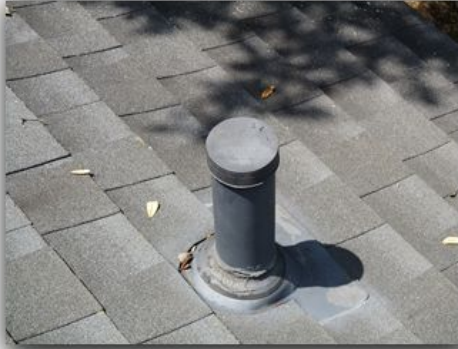
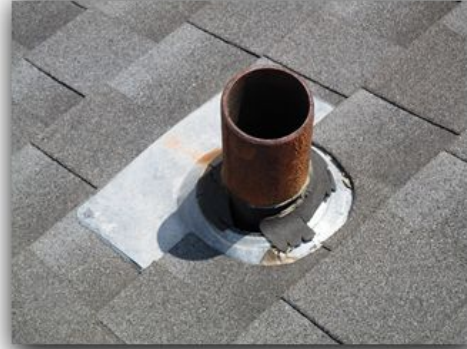
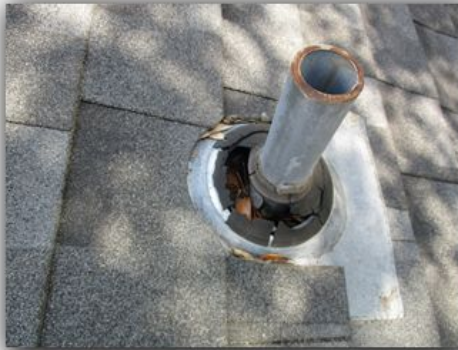
- Roof drain vent boots are deteriorated and letting water into the attic spaces at several locations.
- PVC drain vent at southwest corner of roof (master bathroom) is capped. Recommend removal of cap to achieve efficient drain function.

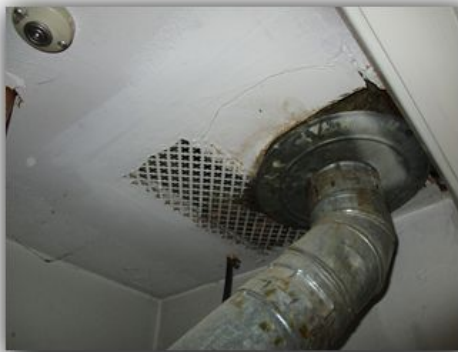
- Air source in the mechanical closet is inadequate for proper combustion at the water heater burner. insulation is covering the vent from the attic side. Insulation should be removed from the screen above the water heater.

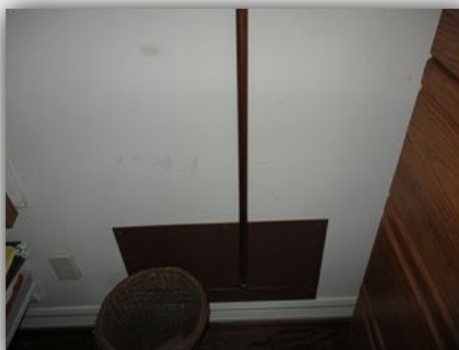
FYI: Evidence previous repairs: Evidence previous repairs to the water supply at vanity sink in north hall bathroom. Recommend asking Seller for more information.

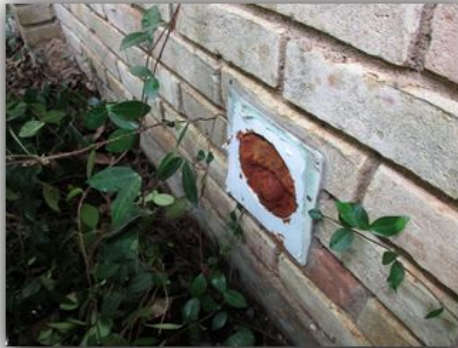
- Could not locate or confirm the presence of the termination point for the dryer exhaust.
