HouseEXAM

PROPERTY INSPECTION REPORT

Concerning: 123 Main Drag, Shangri-La, TX 00001
(Address or Other Identification of Inspected Property)

By: M Victor Sedinger, Lic #7195 12/14/2018
(Name and License Number of Inspector) (Date)

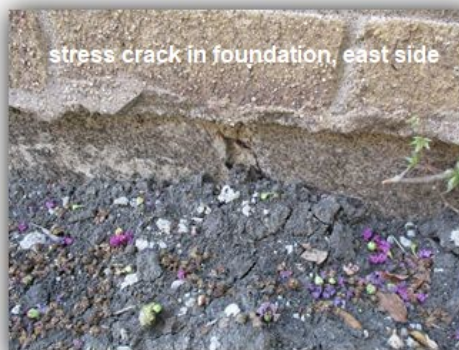
- > Stress cracks have been patched with mortar, in the exterior (brick) veneer.
- > Misalignment of interior doors in relation to their frames, due to foundation movement.
- > Floors slope and/or are notably out of level. See "Floors" section for specific information.
- > Cracks were observed in the floor of the garage.
- > Stress crack(s) observed in the exterior foundation perimeter beam.

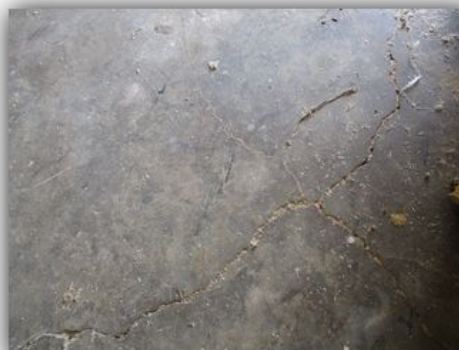
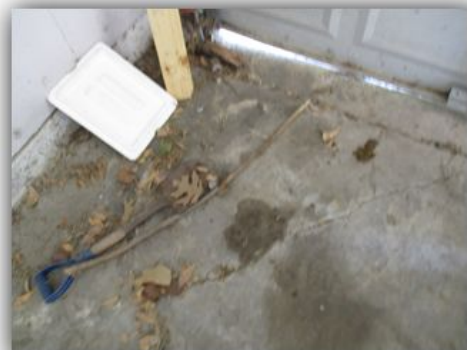
- Notable cracks were observed in concrete surfaces at the garage floor/slab, driveway, patios and/or sidewalks around the house. These cracks should be sealed with a waterproof sealant to better protect soil beneath from erosion, undermining the pavement. Such repairs may be performed by a handyman type service or a qualified cement contractor.

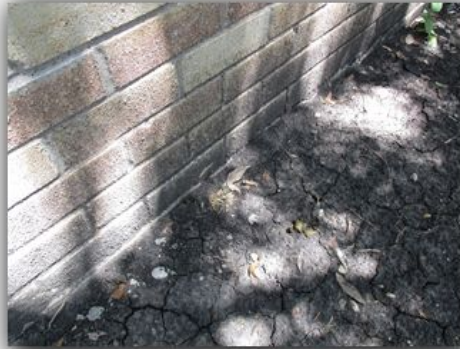
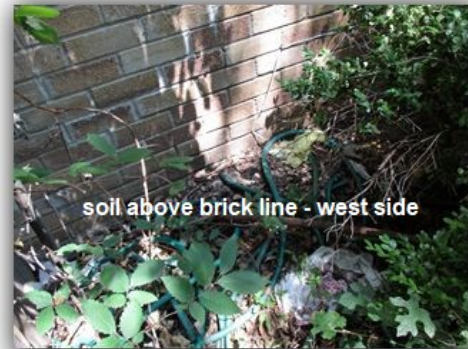
- Soil line at west side(s), is well above brick level. Soil should be removed to 2-4" minimum below the foundation, to maintain clear visual access. Current condition is conducive to wood destroying insect infestation.

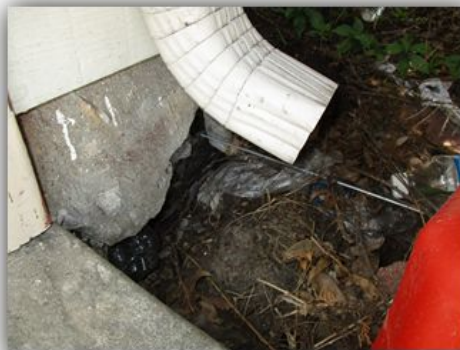
- Observed eroded area at southeast corner of garage, where downspout empties directly at the foundation. It appears that an additional downspout is needed at the front elevation to provide adequate discharge of roof runoff.
- The rain gutter downspouts are terminating directly onto soil at the foundation at two or more locations. Downspout discharge should be extended away from the foundation, or diverter blocks should be added.

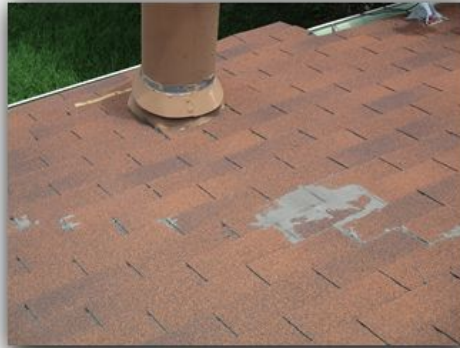
Evidence of Previous Repair: Observed evidence of previous repair to shingles at rear slope, above the chimney. Recommend asking Seller for further information regarding the need for this repair, warranties, etc.

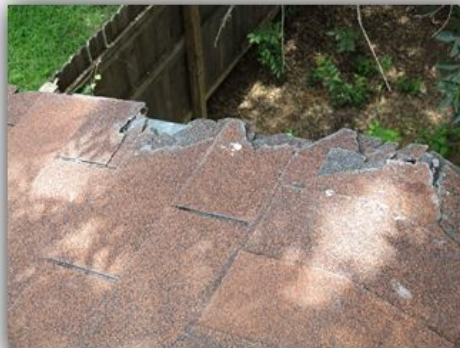
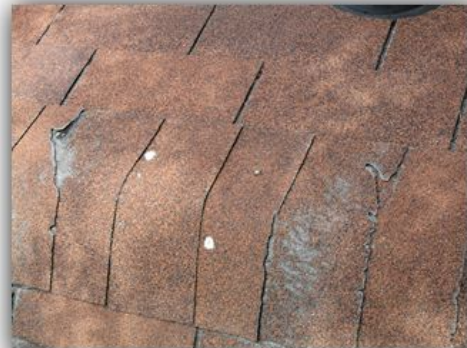
- Bruising and scraping from previous limb contact observed at shingles at west end of roof. Area appears to be in need of repair by a qualified roofing specialist to prevent water intrusion.

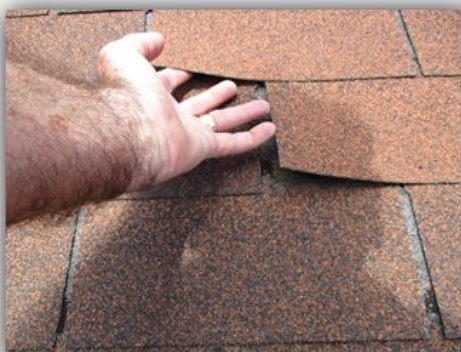
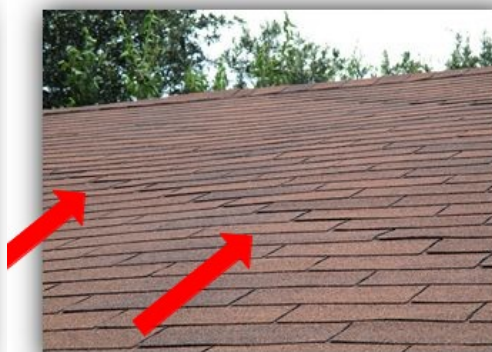
- Shingle rows have not been properly staggered, so that diagonal shingle tab corners appear to be aligned. (see photos below) Bottom corners are not properly sealed down, leaving them vulnerable to wind damage. While no such damage was present at time of inspection, client should monitor these locations over time for wind damage and/or missing shingles. Evaluation of this condition can be performed by a qualified roofing specialist, who can also make further recommendations.

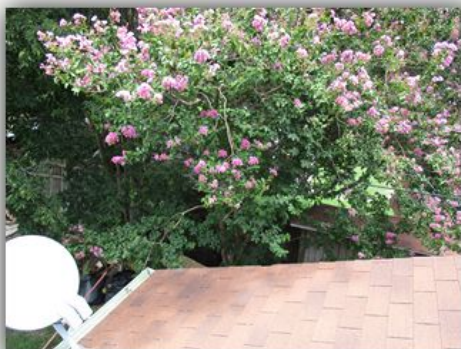
- There are tree limbs and/or shrubs in direct contact with the roof at east side. All trees should be trimmed back 3 to 5 feet from the structure. When trees are close to the house, their limbs should never touch the building, or serious damage can result.

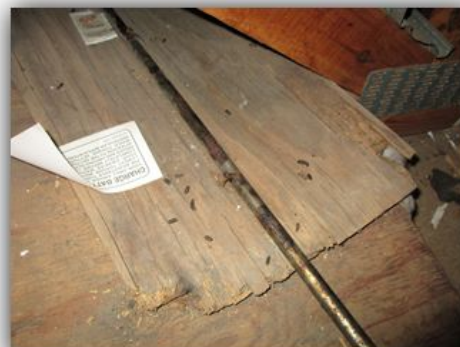
- Evidence of rodent activity was observed in the attic. Traps and/or bait were observed inside the attic. Fairly heavy amounts of feces/droppings were observed inside the attic. Inspector

recommends that Client ask Seller for information regarding such activity and any exterminating activities which may have been performed.

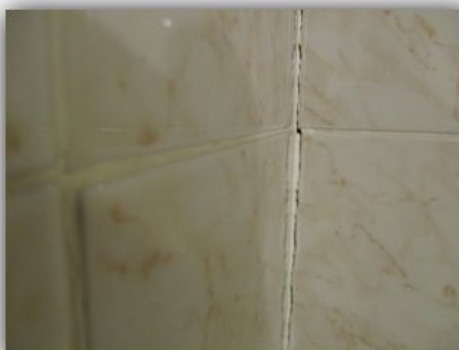
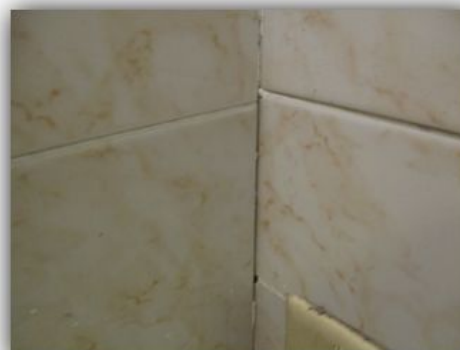
- Grout joints at shower and vanity wall tile is in need of repair at corners. Stress cracks are present in these locations.

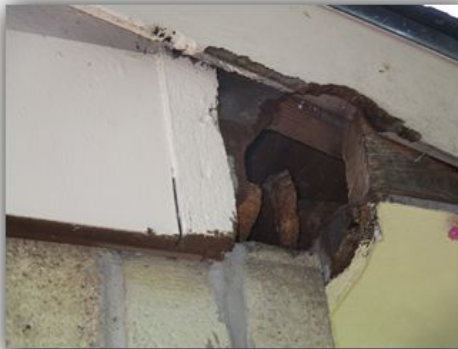
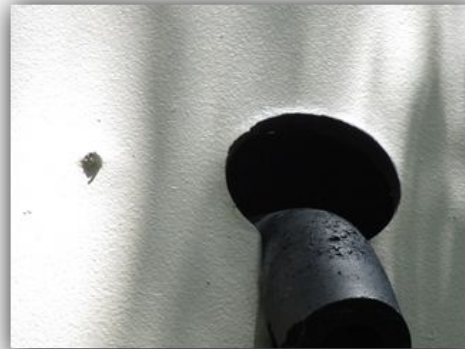
- Several openings were observed at the exterior, which would allow rodent and other vermin entry into the attic spaces. (photo below) Recommend repair of all such openings by a qualified handyman service.

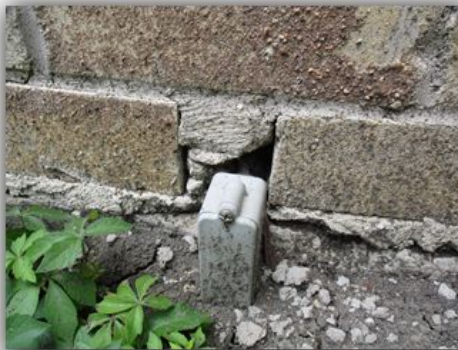
- Observed gap in the brick and mortar at the east side, where electrical cable exits the house for service to the tool shed. Recommend sealing gaps to prevent rodents or vermin from entering the wall cavities.

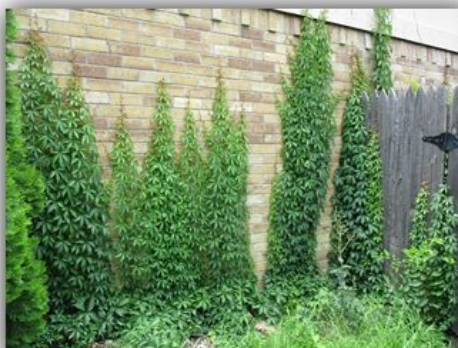
- Observed vegetation/foliage in direct contact with the exterior of the structure. All plants and shrubs should be trimmed 3 to 5 inches away from the structure, to minimize wood rot and potential insect damage in siding and trim.

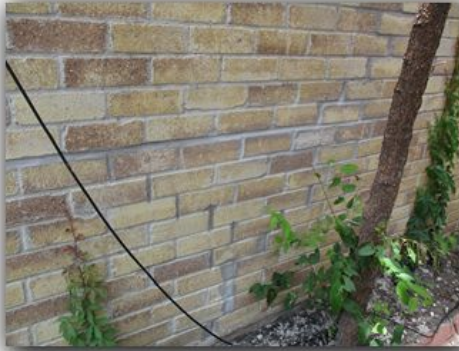
Evidence of Previous Repair: Observed evidence of previous repair to brick and mortar at east side of garage and north side. Recommend asking Seller for further information regarding the need for this repair, warranties, etc.

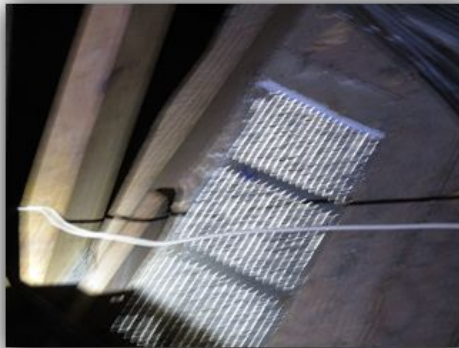
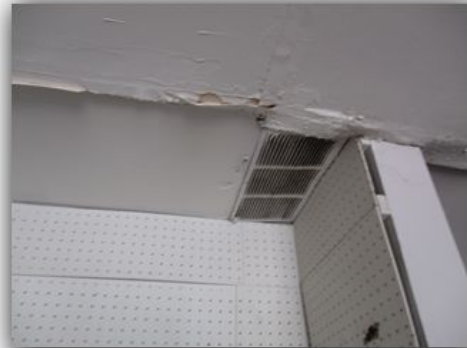
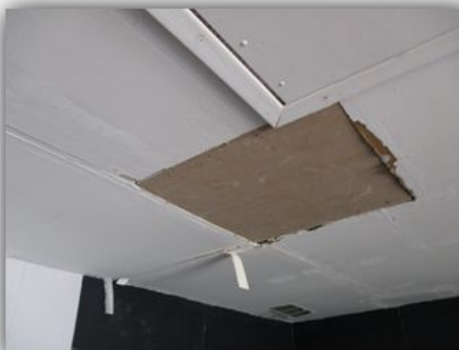
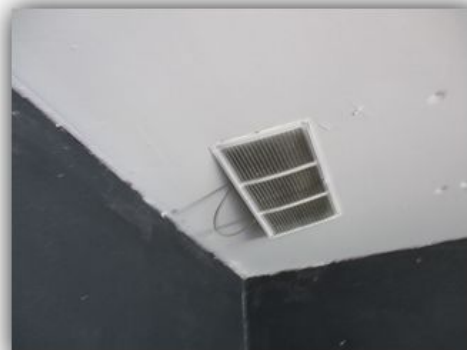
- Hole(s) and/or repaired sheetrock, which has not been properly taped and textured, at garage ceiling, presents a potential breach of the firewall between the garage and the attic. Recommend repair or replacement of the drywall barrier at this location.
- Vent screens in garage ceiling constitute a breach in the fire-rating between garage and attic space. Vent should be removed and holes properly sealed.

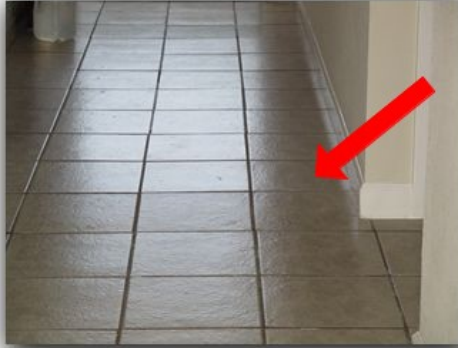
- Uneven, sloping floors observed at family room, entry hall, southwest bedroom, etc. See recommendations for further evaluation in "Foundations" section.
- High spot observed in entry hall floor. Client should monitor these conditions over time and contact a qualified foundation repair specialist if condition worsens or additional signs of deterioration develop..

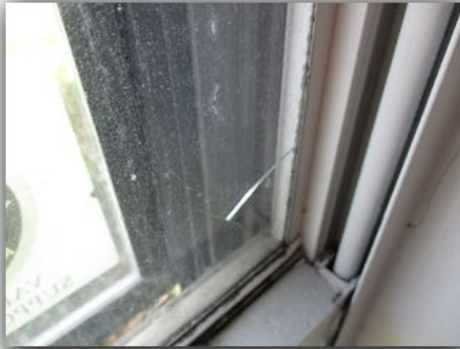
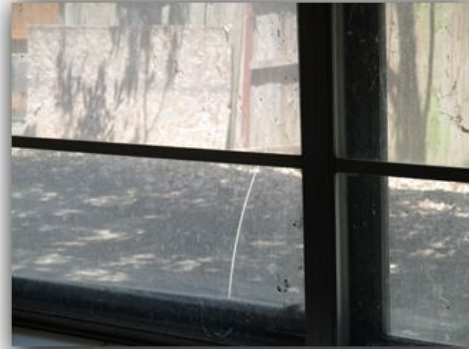
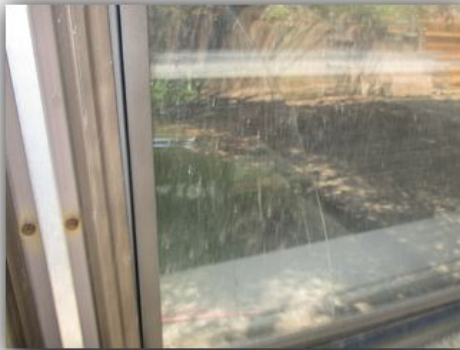
- Glass pane(s) broken at breakfast room/nook and at front bedroom. Recommend repair to prevent further damage or injury.

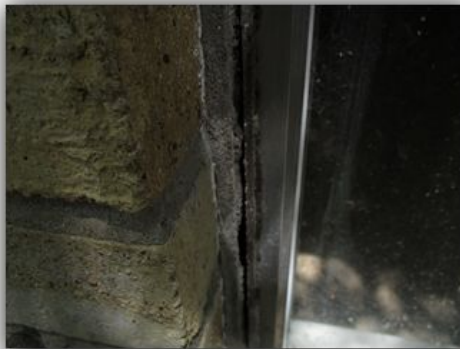
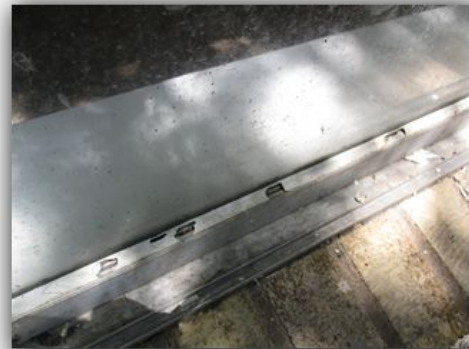
- There are a few windows that are in need of sealing/caulking at the exterior frames. Repairs can be performed by a handyman service, or a painting contractor.
- Plastic glazing bead cracked and damaged, apparently by hail strikes, in several windows.

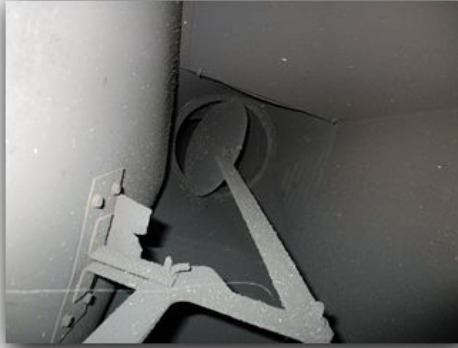
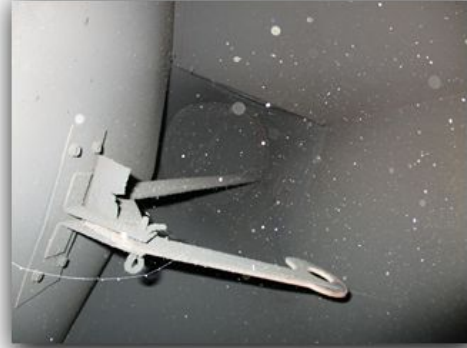
- Observed light-to-moderate amount of creosote build up inside the chimney flue. Periodic cleaning by a professional chimney sweep or certified chimney technician is recommended.

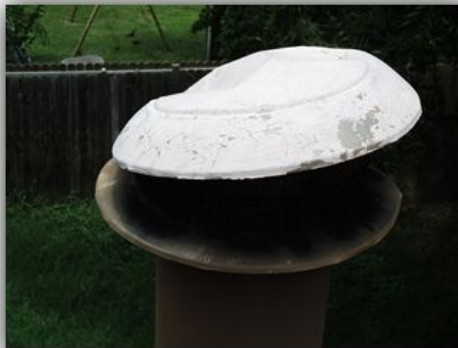
- Rain cap at top of chimney has been damaged, and may be restricting exit of smoke from the fireplace. Any evaluation or subsequent repairs should be performed by a certified chimney technician.

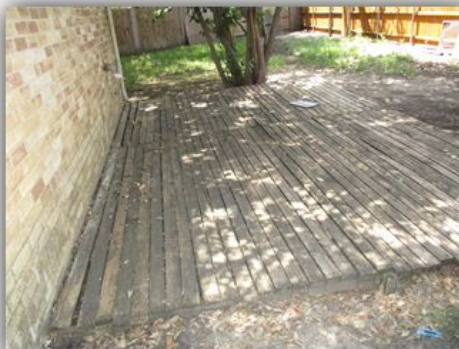
- Wooden deck at rear has been constructed directly onto the soil. Recommend removal of this structure, or reconstruction using proper building methods. This is a condition considered conducive to wood destroying insect infestation.

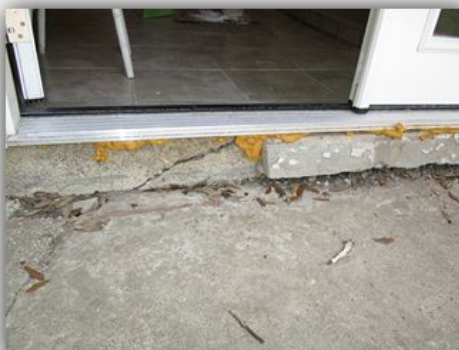
- Concrete threshold at rear entry door is broken, and should be repaired to provide proper support to metal threshold at the doorway.

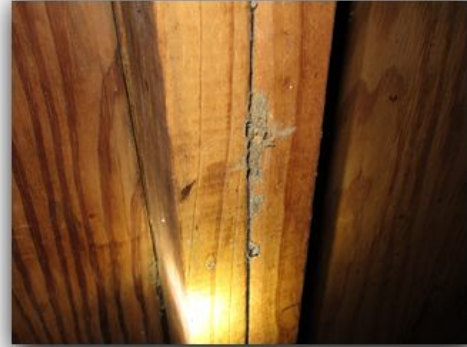
- Observed slight water damage to the cabinet floor under the kitchen sink.
- There is notable deterioration of the fence that is surrounding the property. While this condition is not reportable as deficient regarding the structure, Client should make budgetary provisions for repair.
- Wooden shed at east side in back yard is in need of replacement. Observed evidence of previous sub-terranean termite infestation at interior wood framing members. (Inspector is a licensed Pest Control Technician, TPCL #0598337). Cosmetic damage should be repaired. No evaluation of sub-surface damage is possible without destructive analysis. Due to lack of evidence of previous treatment, Inspector recommends treatment of the structure by a licensed pest control applicator, as needed.

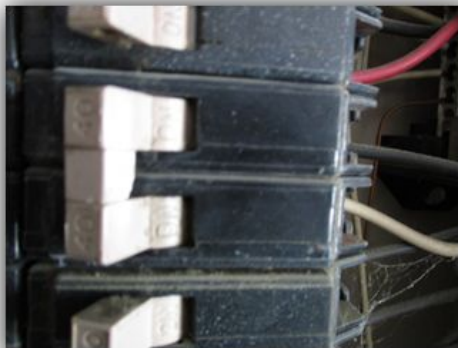
- Breaker size(s) mismatched to wire gauge size(s) at one or more locations in the panel. 40-amp breaker, third from top right, is oversized for the 10-gauge wires currently attached. **FYI:** A smaller size wire will not trip an larger size breaker. Any evaluation or repairs to electrical components should be performed by a licensed electrician.

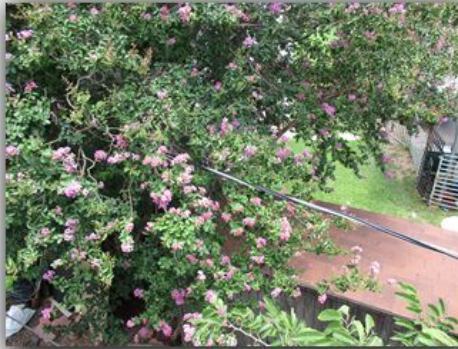
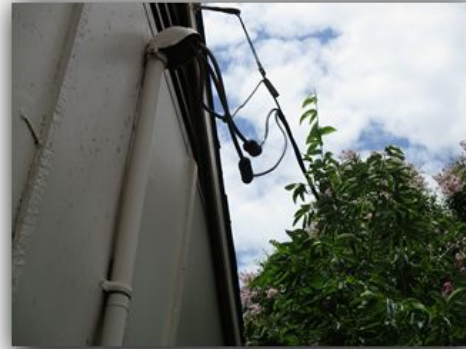
- Tree limbs are heavily in contact with the electrical service entry wires. Recommend contacting the utility company to enquire about trimming these limbs back.

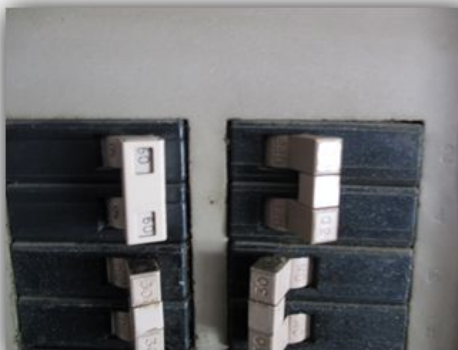
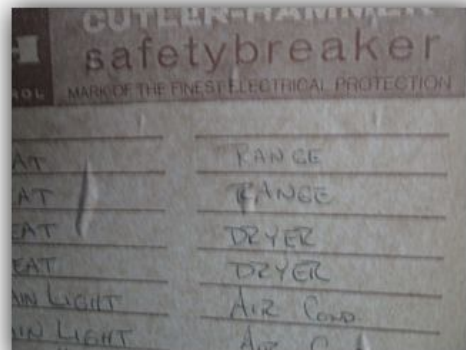
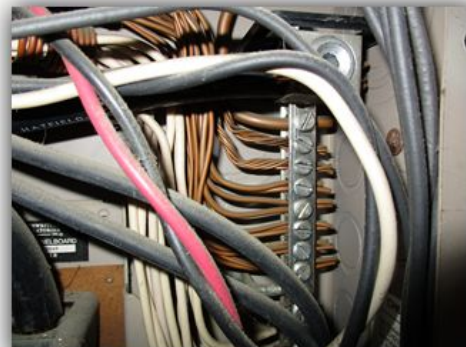
- The electrical panel does not have a single main disconnect breaker. In addition, a complete disconnect can **NOT** be accomplished within 6 swipes of the hand. Current electrical codes consider this condition a safety hazard in the event of an emergency, and a licensed electrician should evaluate and repair as needed.
- Main electrical panel is a "split bus" type panel, requiring all breakers to be turned off in an emergency. This is an "as built" condition, and repairs would require an updating of the equipment. Per Standards of Practice, the inspector is required to report the current condition as "deficient."

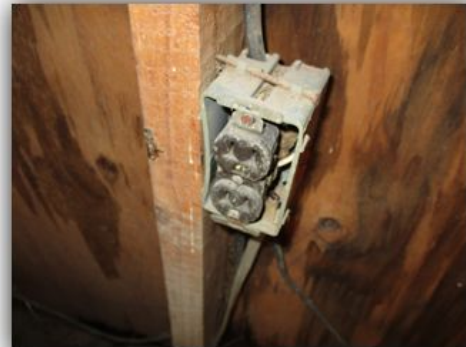
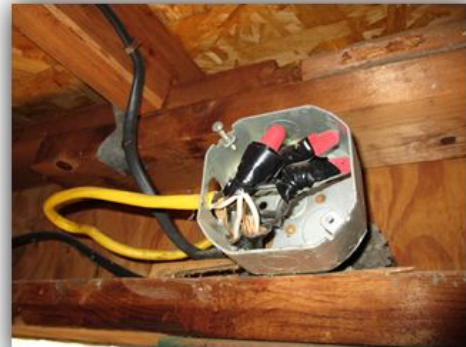
- Cover plates are missing at switches and receptacles in the wooden tool shed at east side of backyard.
- Observed exposed wiring cables/splices/connections at wooden tool shed. All electrical connections of this type are required to be enclosed inside an accessible junction box, with a cover plate.

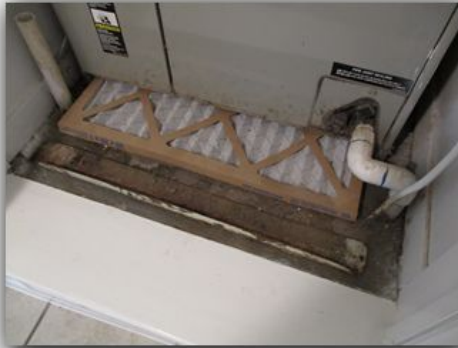
- Wrong size filter is present. Access door does not fit, leaving evaporator open to air infiltration from the mechanical closet. Any evaluation or subsequent repairs should be performed by a licensed HVAC technician.

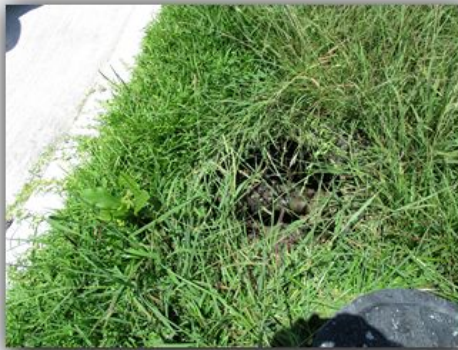
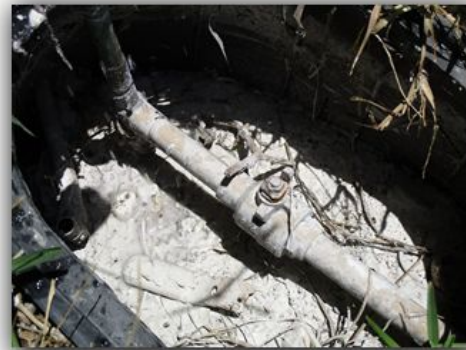
- There does not appear to be a meter present at the pit by the curb. Recommend asking Seller for more information. Any evaluation or subsequent repairs should be performed by a licensed plumber.
- Handle is missing from the shut off valve for the house (front yard in pit).
- Handle is missing from rear exterior hose bib.
- The exterior hose bibs do not have a back flow prevention valve installed.

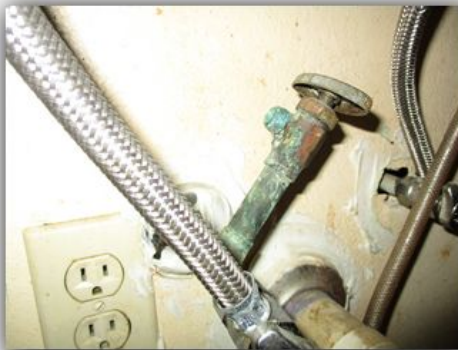
- Shut off valve for the dishwasher supply. under the kitchen sink does not flow when opened. Recommend replacement of valve if necessary, when dishwasher is to be installed.

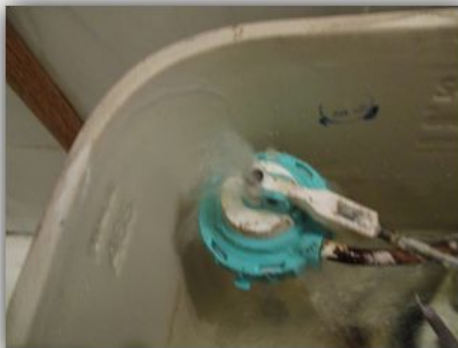
- Hall bathroom shower diverter lever is stuck in the "on" position and will not release. Also, tub spout continues to run when shower is engaged. Any evaluation or subsequent repairs should be performed by a licensed plumber.
- The toilet is loose at the floor mounting in the hall bathroom. Also, the ball cock (fill valve) at the interior of the tank.
- The lever is missing or broken at the house shut off valve in front yard pit (photo below).
- The exterior hose bibs do not have a back flow prevention valve installed.

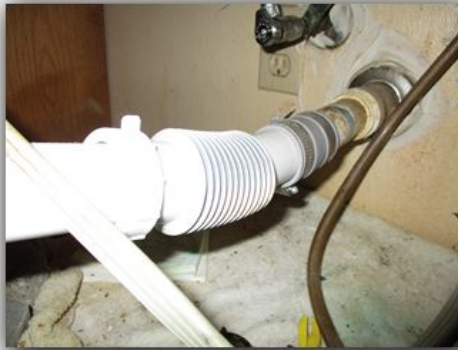
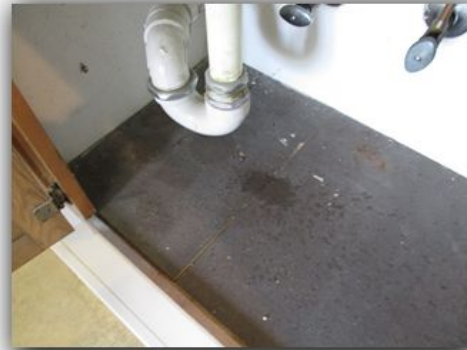
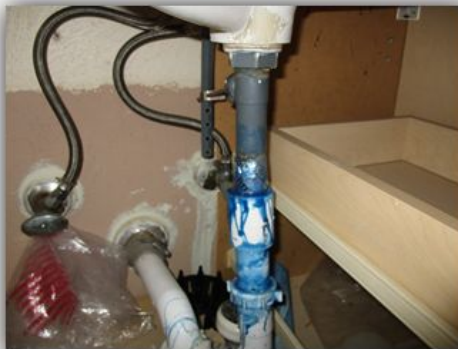
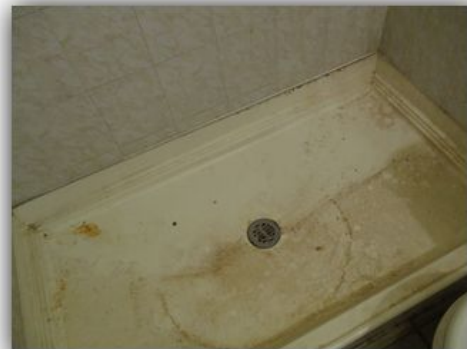
- Slow drain at shower in master bathroom. Also, water stands in a low-lying portion of shower pan.
- Observed leak at the drain fittings under the wet bar sink. A handyman service or licensed plumber can perform such repairs
- Repairs to the drain fittings under the hall bathroom vanity sink appear to be less than workmanlike in quality, and may not prevent leaks. (photo below)
- Plastic flex type drain fittings (such as the one at the kitchen sink) are prone to clogging and does not serve as a proper P-trap for sanitary drain. Recommend replacement of this fitting by an approved drain fitting.
- Drain pop-up is missing at hall bathroom vanity sink.
- Mechanical drainstop at hall bathroom tub is missing.

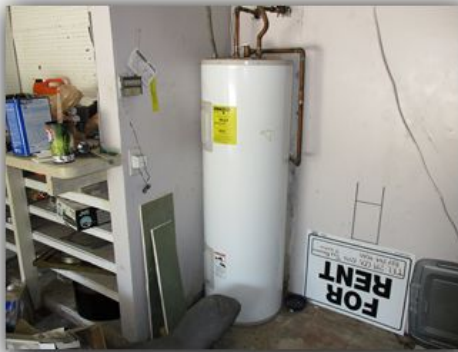
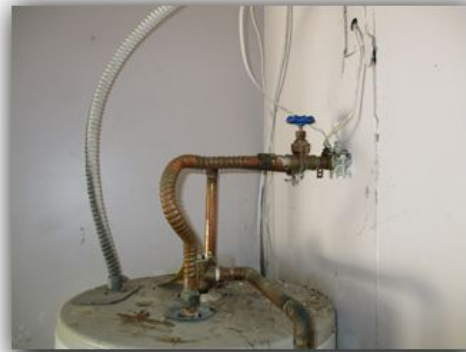
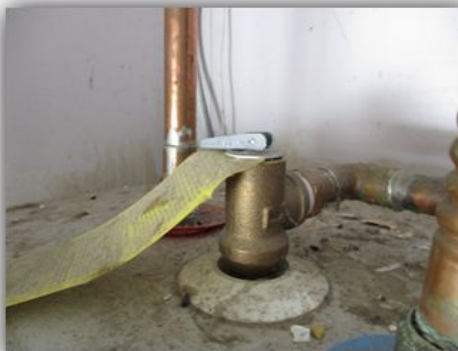
- Recommend replacement of Temperature & Pressure Relief valve, due to age of device and water heater.
- The water heater is not sufficiently elevated off the garage floor to prevent gas fume combustion. Under current installation standards, water heaters should be installed a minimum of 18" above the lowest point in the garage floor. This is an "as-built" condition, but TREC standards of practice require the current condition be reported as "deficient."
- Insulation is damaged or missing at water lines to the water heater.

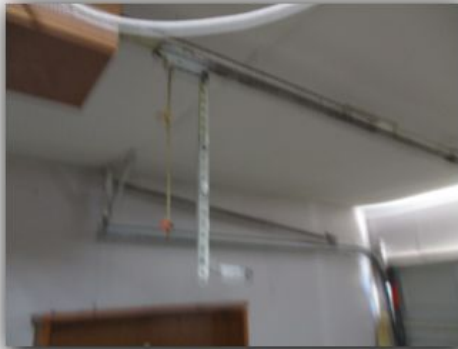
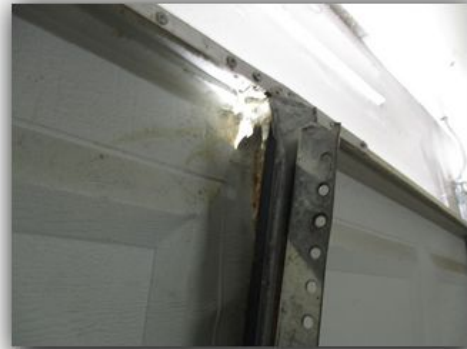
- East side door operator assembly is in need of repair or replacement. Trolley arm is disconnected, and attachment point on door has been improperly repaired, without reinforcement to the panel. Under current conditions, it is not advisable to operate this automatic opener. Any evaluation or subsequent repairs should be performed by a certified garage door operator installer/contractor.

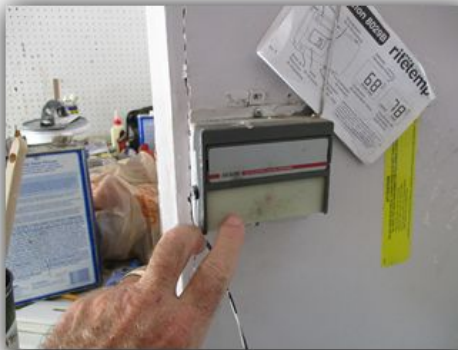
- Operator on west side overhead garage door is in need of repair. Closing the overhead garage door operator requires holding the button for the full close cycle. When the button is released during close cycle, the door reverses itself.
