HouseEXAM

PROPERTY INSPECTION REPORT

Concerning: 13579 Grumbling Lane, Fort Worth, TX 76001
(Address or Other Identification of Inspected Property)

By: M Victor Sedinger, Lic #7195 01/27/2019
(Name and License Number of Inspector) (Date)

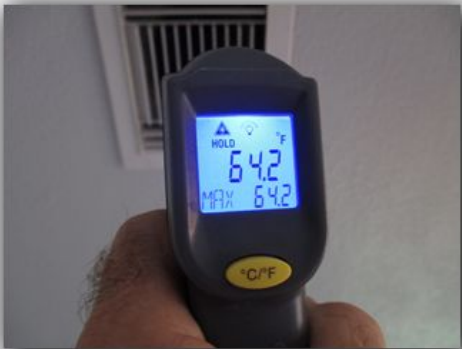
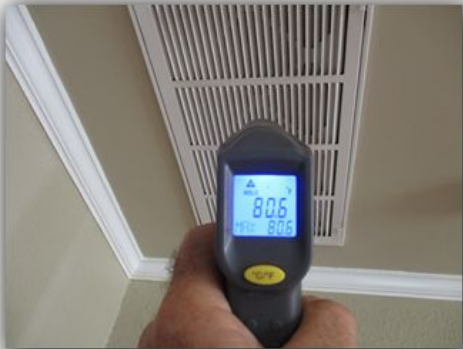
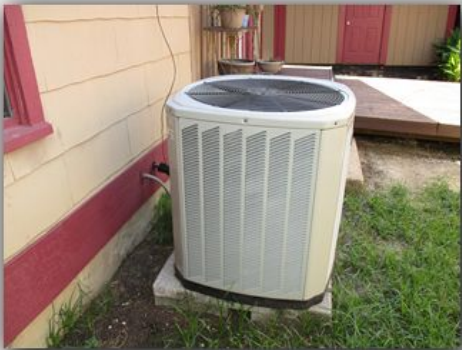
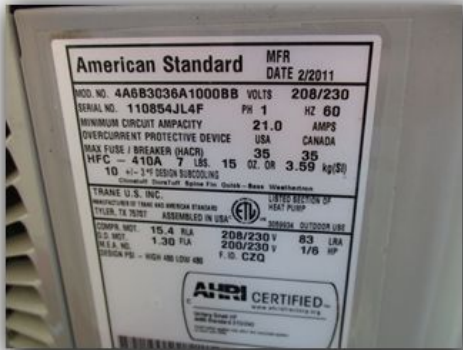
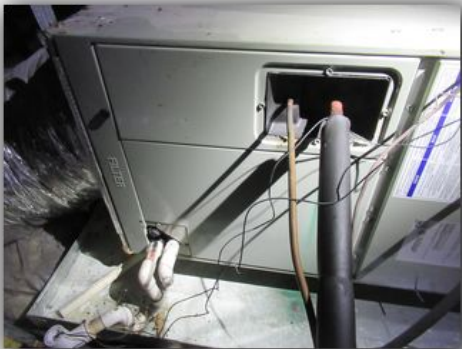
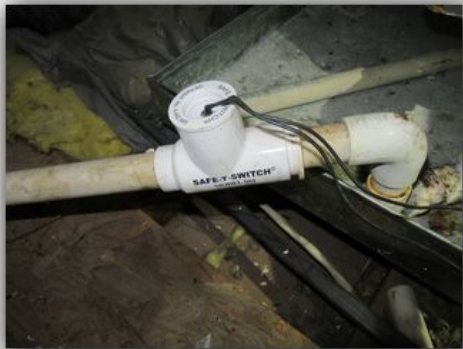
There is one air conditioning system present:
Condenser is made by American Standard, 2011 model, 3 ton
Evaporator (indoor component) made by same manufacturer? Yes
Actual temperatures measured at supply and return air grilles in the house
Supply Air Temp: 64° Return Air Temp: 80° Differential: 16°
The temperature differential is within the range of 15°-21°.
