HouseEXAM

Report ID: Slab on Grade Sample

PROPERTY INSPECTION REPORT

Concerning: 123 One Hundred Twenty-third Street, Fort Worth, TX 76001
(Address or Other Identification of Inspected Property)

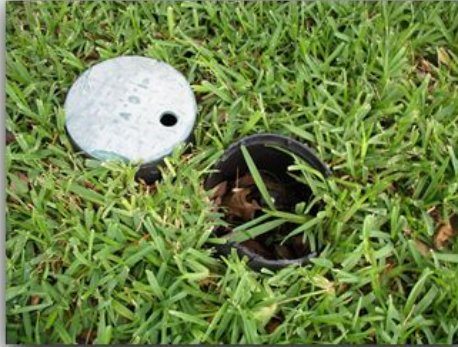
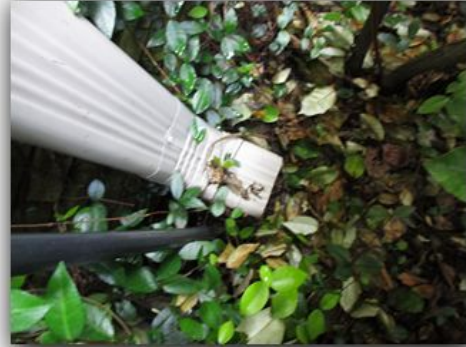
FYI: Monitor drainage conditions on north end: The structure has been built downhill from street level on the northeast corner of the lot. While a visual assessment at the time of the inspection showed no obvious effects of flooding or water damage, extra caution should be taken to prevent any possible water intrusion to the structure. For example, do not construct or assemble flowerbed borders that will cause a damming effect and hold water next to the structure. Positive drainage slopes and angles should always be maintained. And remedial measures should be sought for any areas where water ponds for more than 24 hours around the immediate perimeter.

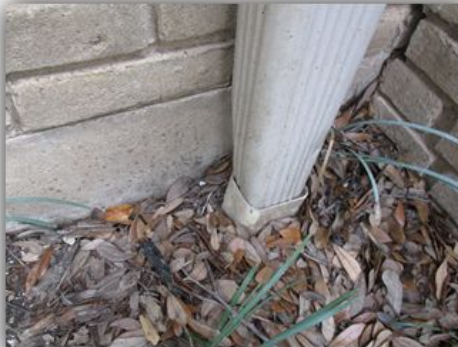
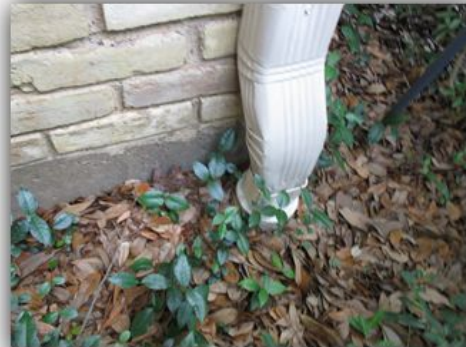
FYI: Sub-surface Drainage Present: A sub-surface drainage system is present on the the east side. Termination point of the sub-surface lines was not located.. Testing of the system is beyond the scope of this inspection. However, the owner should examine it for clear access, and keep grass and debris from blocking the collection grids or termination points.

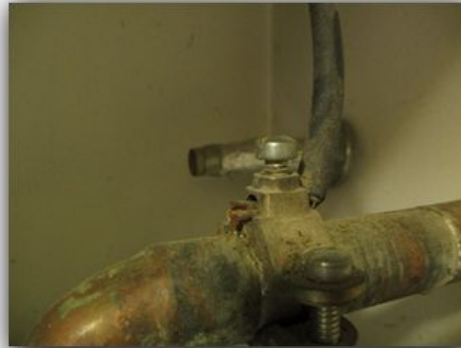
Grounding method(s): Cold Water Ground (photo below)

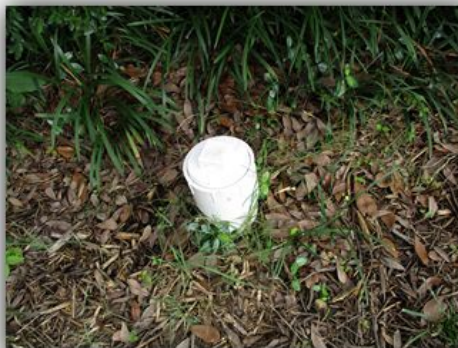
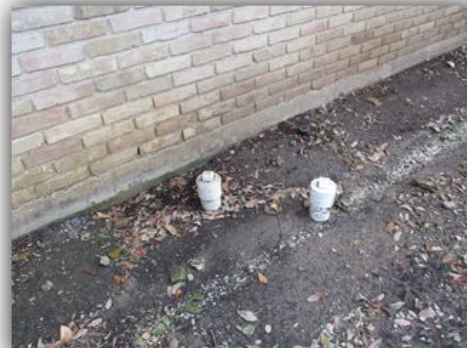
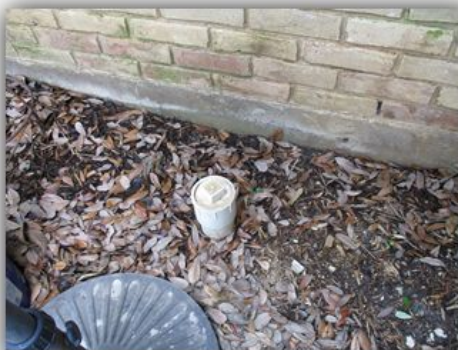
FYI: Evidence previous repair to waste/sewer lines: The number of PVC cleanout hubs around the south and east sides of the house would indicate previous repairs to, or replacement of, cast iron sewer lines. Recommend asking Seller for more information, especially for information and documentation of permits, licenses, warranties, etc.

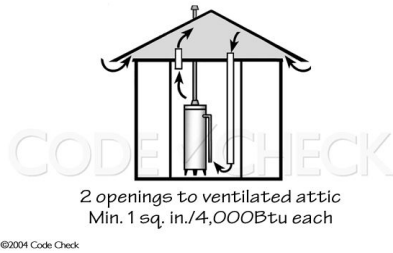
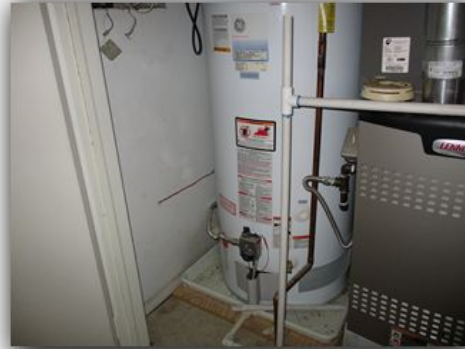
Combustion Air - Attic Space Source

- Air source in the mechanical closet is inadequate for proper combustion at the water heater burner. insulation is covering the vent from the attic side. Insulation should be removed from the screen above the water heater.

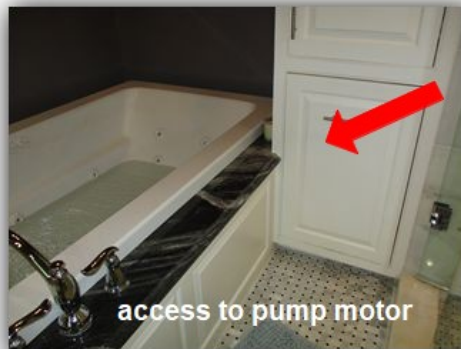
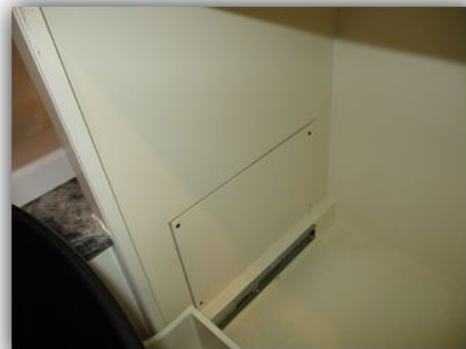
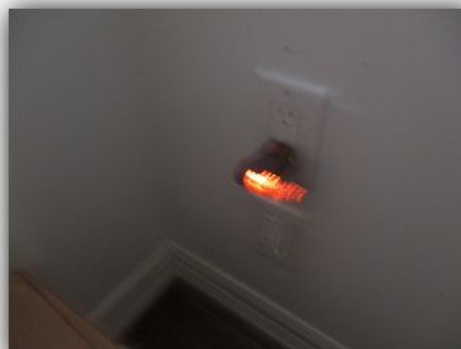
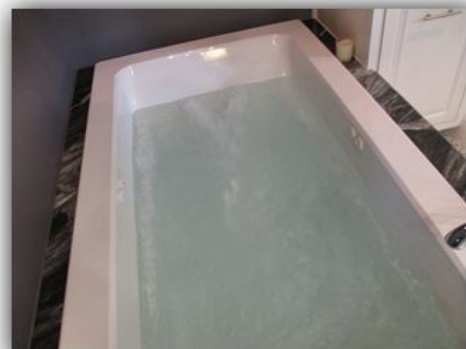
General Information: A whirlpool tub is present. The tub was filled to a level above the water jets and operated in "normal" mode, to check intake and jets. The items tested appeared to be in serviceable condition. Ground fault protection for servicing the motor was confirmed to be available inside the middle bedroom closet

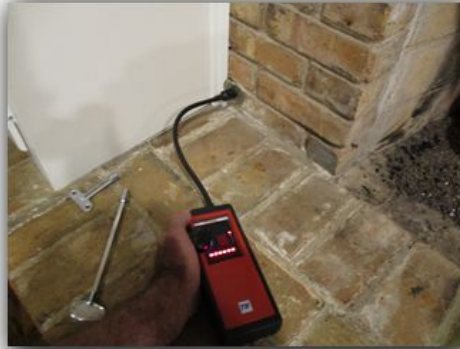
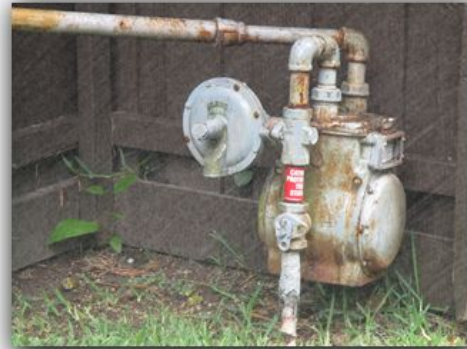
Gas distribution piping materials: Rigid black pipe

Gas meter (shut-off valve) location: West side, in the alley
