HouseEXAM

PROPERTY INSPECTION REPORT

Concerning: 123 Main Drag, Shangri-La, TX 00001
(Address or Other Identification of Inspected Property)

By: M Victor Sedinger, Lic #7195 12/14/2018
(Name and License Number of Inspector) (Date)

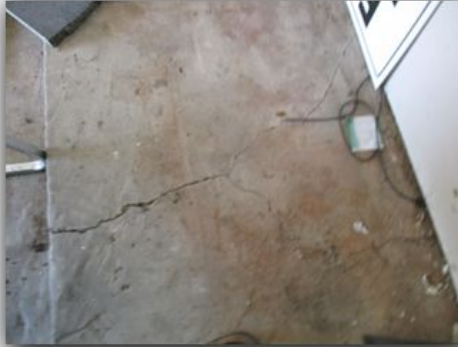
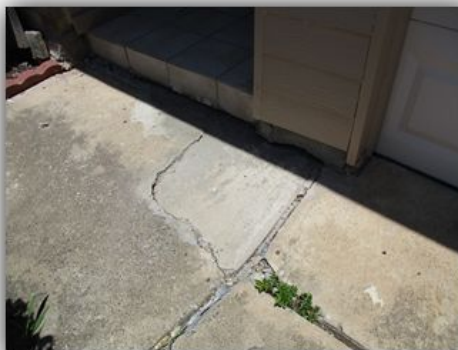
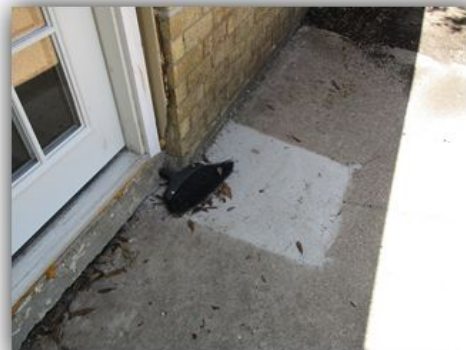
- > Stress cracks have been patched with mortar, in the exterior (brick) veneer.
- > Misalignment of interior doors in relation to their frames, due to foundation movement.
- > Floors slope and/or are notably out of level. See "Floors" section for specific information.
- > Cracks were observed in the floor of the garage.
- > Stress crack(s) observed in the exterior foundation perimeter beam.

Foundation Repair Information: It appears that previous foundation repairs have been performed at this residence. Inspector recommends that Client obtain as much written information and documentation as possible ***prior to closing this real estate transaction***. Such documentation would identify the company that performed the repairs, as well as warranty documents, permits (where required), plumbing tests performed after repairs, and any other inspection reports.

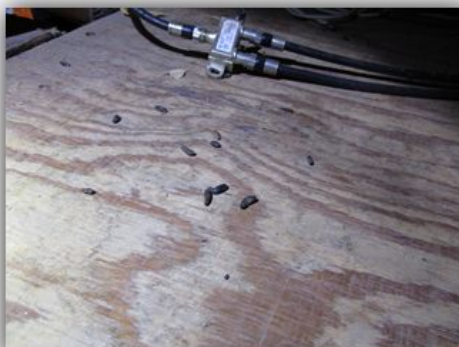
- Several openings were observed at the exterior, which would allow rodent and other vermin entry into the attic spaces. See details and recommendation(s) for further evaluation in "Walls (Exterior)" section. Recommend repair of all such openings by a qualified handyman service.

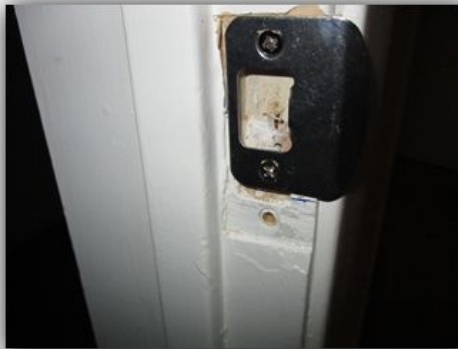
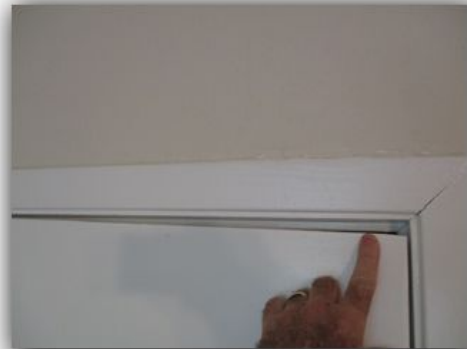
- Doors will not remain stationary at two front bedrooms, and at southwest bedroom closet (continue to move when released).
- Door does not fitting squarely inside the door frame at closet in master bedroom.
- Closet door in master bedroom does not latch properly, and appears to have had its striker plate adjusted more than once in the past.

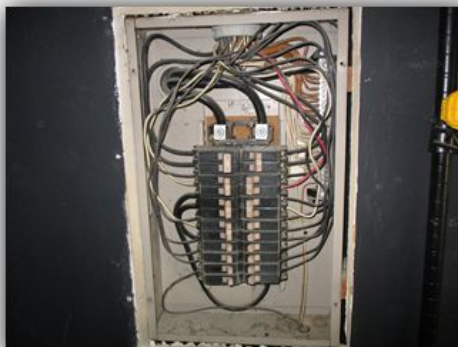
- The electrical panel does not have a single main disconnect breaker. In addition, a complete disconnect can **NOT** be accomplished within 6 swipes of the hand. Current electrical codes consider this condition a safety hazard in the event of an emergency, and a licensed electrician should evaluate and repair as needed.
- Main electrical panel is a "split bus" type panel, requiring all breakers to be turned off in an emergency. This is an "as built" condition, and repairs would require an updating of the equipment. Per Standards of Practice, the inspector is required to report the current condition as "deficient."

Based on the issues described in this section of the report, Inspector recommends that a licensed electrician, evaluate the electrical service and panels at the structure, prior to the close of the option period ***or any other applicable time restraints.***

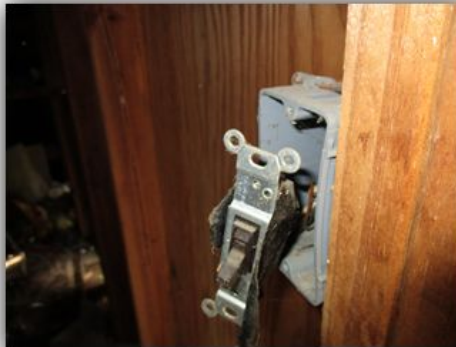
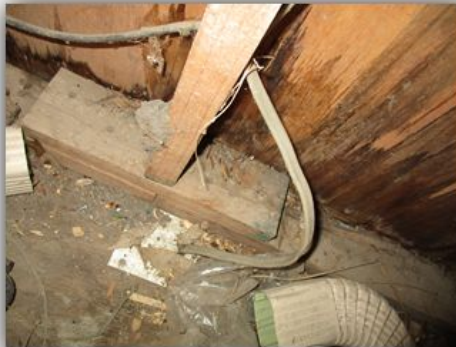
Outbuilding (Tool shed)

- Cover plates are missing at switches and receptacles in the wooden tool shed at east side of backyard.
- Observed exposed wiring cables/splices/connections at wooden tool shed. All electrical connections of this type are required to be enclosed inside an accessible junction box, with a cover plate.

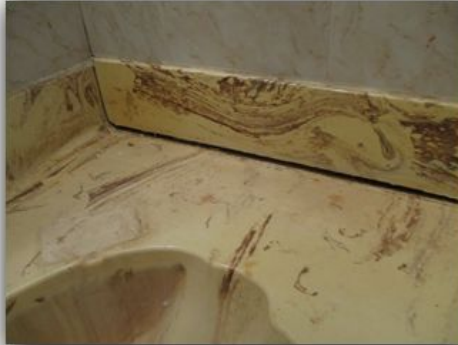
- Shower control handle has no "off detent" (does not stop at off).
- Vanity sink backsplash is in need of additional caulking and/or grout at master bathroom.

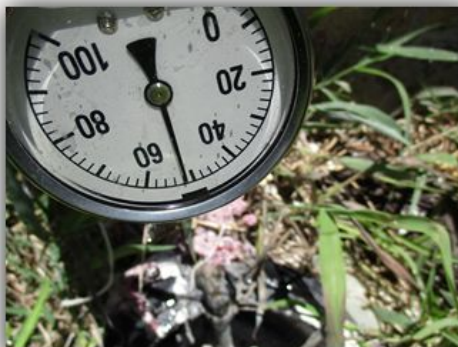
- Hall bathroom shower diverter lever is stuck in the "on" position and will not release. Also, tub spout continues to run when shower is engaged. Any evaluation or subsequent repairs should be performed by a licensed plumber.
- The toilet is loose at the floor mounting in the hall bathroom. Also, the ball cock (fill valve) at the interior of the tank.
- The lever is missing or broken at the house shut off valve in front yard pit (photo below).
- The exterior hose bibs do not have a back flow prevention valve installed.
